The Historical Centre of Porto
Building Characterization

Building Characterization

Urban front analysis

The Caldeireiros Street

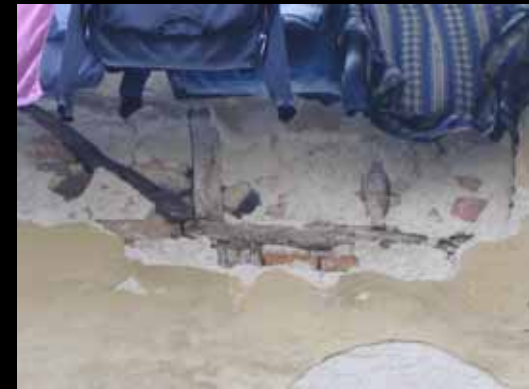
Campo Mártires da Pátria, n.º 148, 149 e 150

Preservation state : **Shallow**

Anomalies : vertical crevice at embrasure in load points; falling tiles and use of strong mortar in the cracks; stone incrustation; badly preserved window-frame

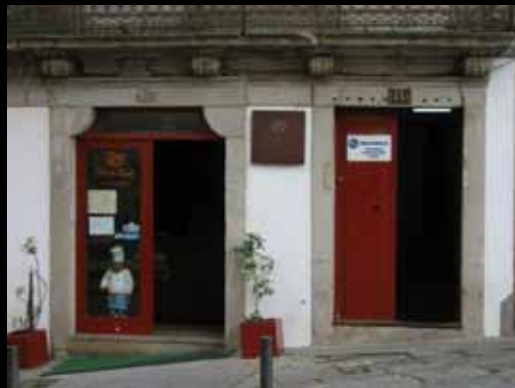
Rua dos Caldeireiros, n.º 265, 263 e 265

Preservation state : **Elevated**

Anomalies : strong mortar; introduction of a new constructive system and materials

Observation : reconstruction works (XXI)

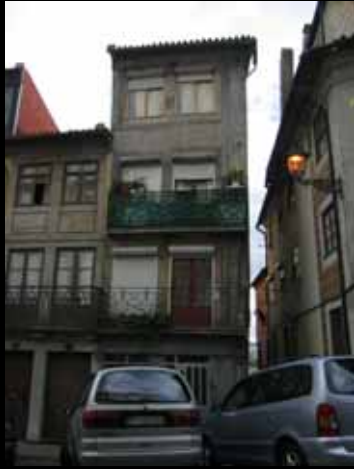
Rua dos Caldeireiros, n.º 247 e 249

Preservation state : **Shallow**

Anomalies : structural sitting and deformation; balcony stone with crevice

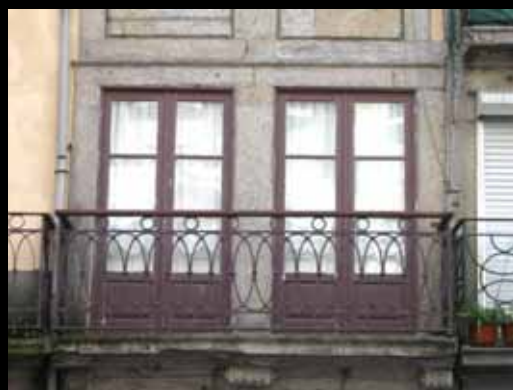
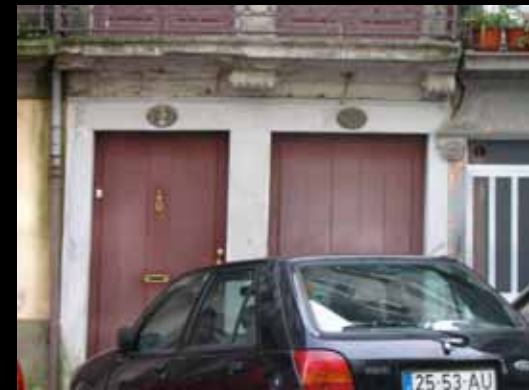
Rua dos Caldeireiros, n.º 243 e 245

Preservation state : **Shallow**

Anomalies : structural deformation on the ground-floor; vegetable colonization; stone incrustation

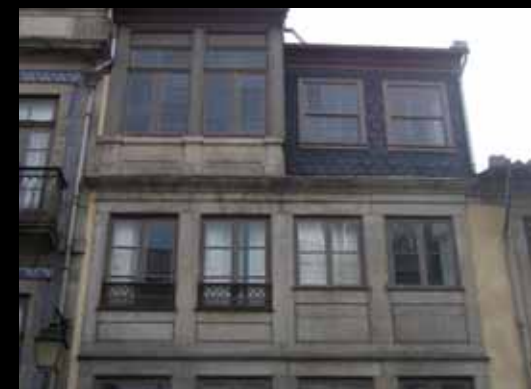
Rua dos Caldeireiros, n.º 239 e 241

Preservation state : **Shallow**

Anomalies: some structural deformation on the ground-floor; vegetable colonization; stone incrustation

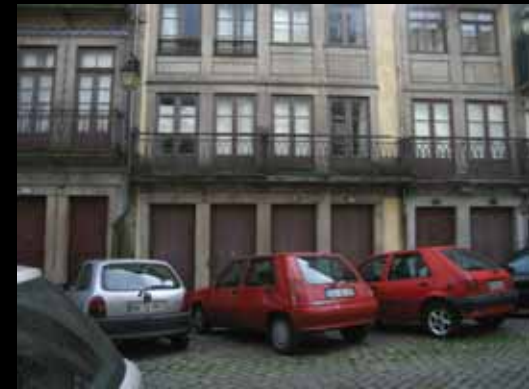
Rua dos Caldeireiros, n.º 237 e 239

Preservation state : **Moderate**

Anomalies: stone incrustation

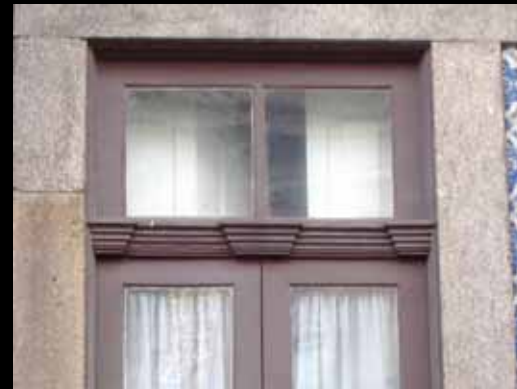
Rua dos Caldeireiros, n.º 231, 233 e 235

Preservation state : **Moderate**

Anomalies: stone incrustation; badly preserved wood window-frames

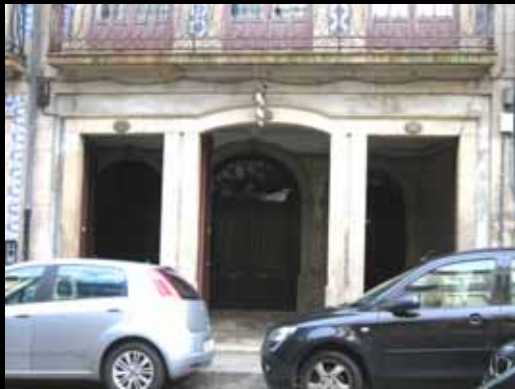
Rua dos Caldeireiros, n.º 227 e 229

Preservation state: **Elevated**

Anomalies: stone incrustation

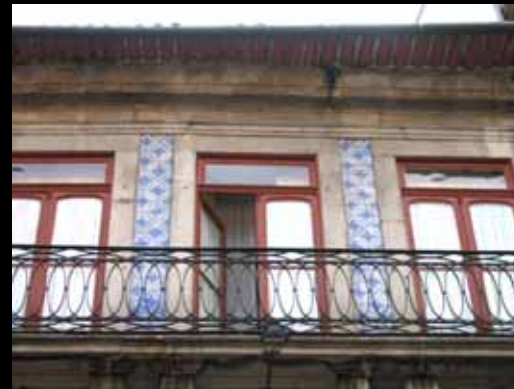
Rua dos Caldeireiros, n.º 221 e 223

Preservation state: **Elevated**

Observation: reconstruction works

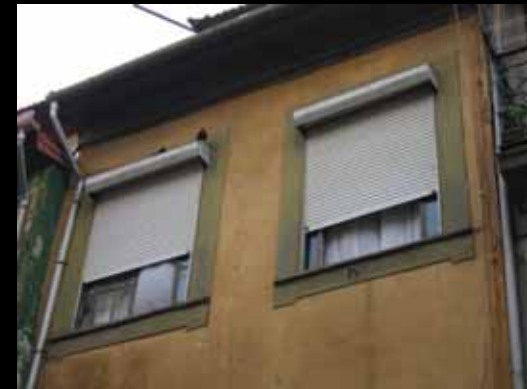
Rua dos Caldeireiros, n.º 207 e 209

Preservation state: **Scanty**, in ruin process

Anomalies: structural decay; structural sitting with vertical crevice; wood putrefaction

Observation: total structural decay (2006). It was interdicted in 2007.

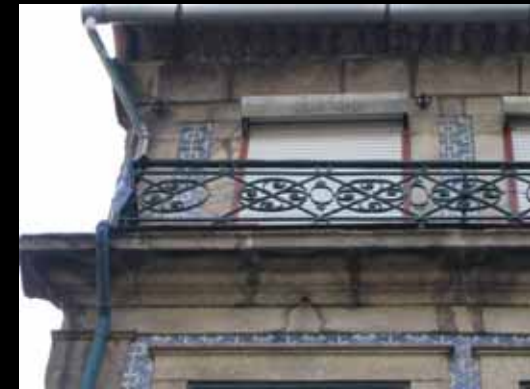
Rua dos Caldeireiros, n.º 191 e 193

Preservation state: **Scanty**

Anomalies: vertical crevice; stone incrustation; strong mortar in the stone joints

Observation: structural decay

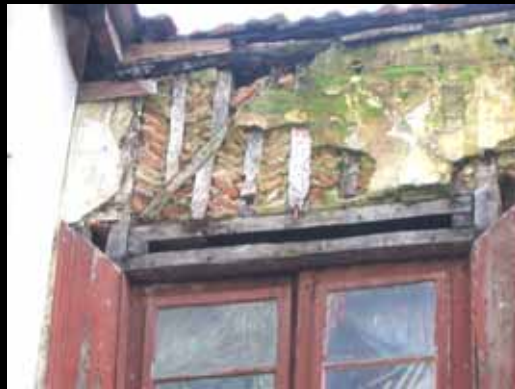
Rua dos Caldeireiros, n.º 181 e 181A

Preservation state: **Moderate**

Anomalies: ink rise up in blisters; humidity stains

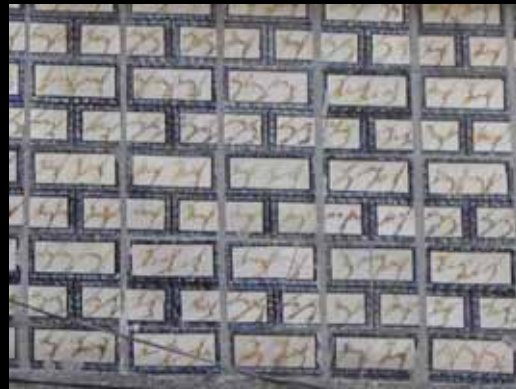
Rua dos Caldeireiros, n.º 167, 169, 171 e 173

Preservation state: **Elevated**

Anomalies: vegetable colonization

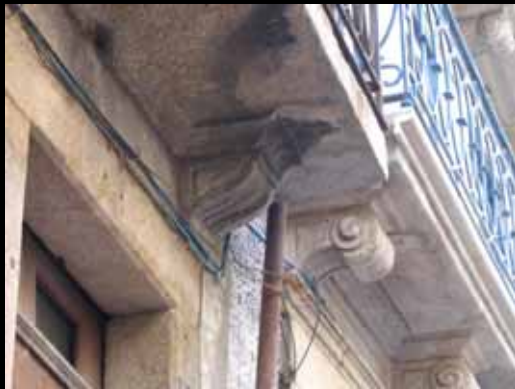
Rua dos Caldeireiros, n.º 131, 133 e 135

Anomalies: structural decay; vertical crevices; sitting foundation; vegetable colonization; stone incrustation; badly preserved window-frames

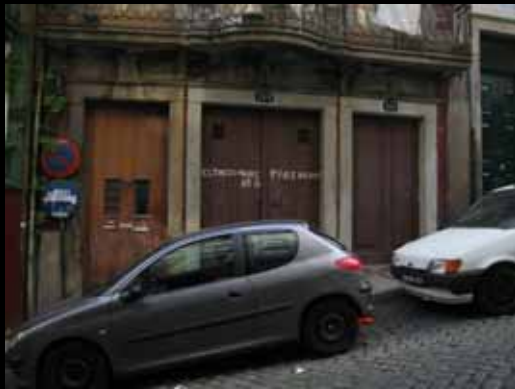
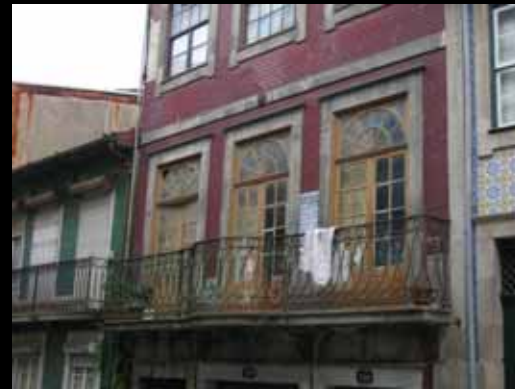
Rua dos Caldeireiros, n.º 103 e 105

Anomalies: structural deformation; vegetable colonization; stone
incrustation; wood putrefaction; tiles rise up; painted stone

Observation: decay process

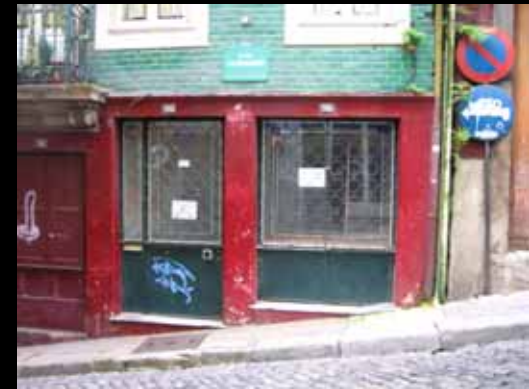
Rua dos Caldeireiros, n.º 99 e 101

Anomalies: structural deformation; vegetable colonization; wood putrefaction; tiles rise up; painted stone; granular disintegration

Observation: decay process

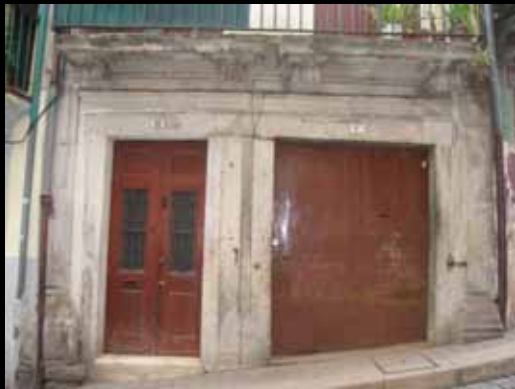
Rua dos Caldeireiros, n.º 91 e 93

Anomalies: structural deformation; vertical crevice; wood putrefaction

Observation: structural decay

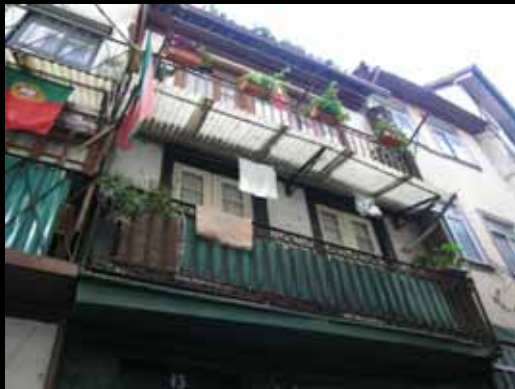
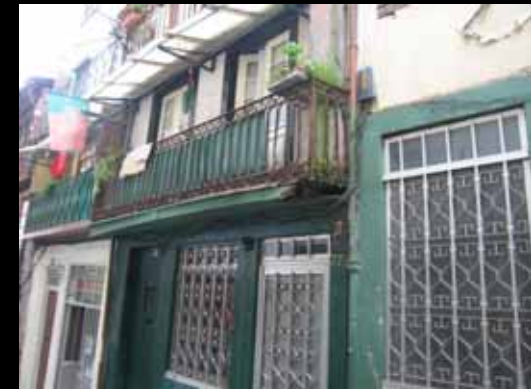
Rua dos Caldeireiros, n.º 73 e 71

Anomalies: lost of horizontality in the structural elements; wood
putrefaction

Observation: structural decay

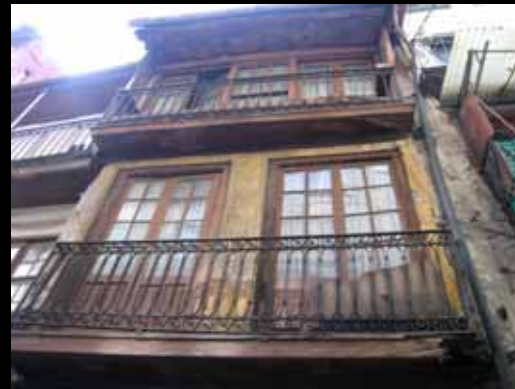
Rua dos Caldeireiros, n.º 63 e 65

Anomalies: wood putrefaction; stone incrustation; new materials and structure

Observation: structural decay

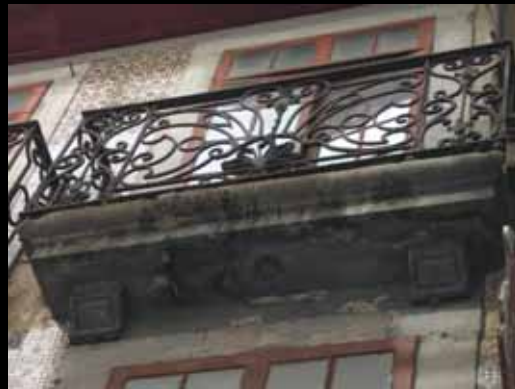
Rua dos Caldeireiros, n.º 53, 55 e 59

Anomalies: structural deformation; vertical crevice with façade
displacement

Observation: total structural decay

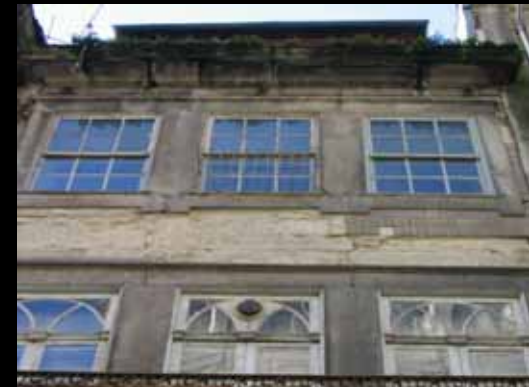
Rua dos Caldeireiros, n.º 1 e 3, 5 e 9, 15, 13 e 11, 17, 19 e 19A, gaveto com a Rua das Flores, n.º 187 e 189

Anomalies: stone incrustation; rough-cast rise up; humidity stains; badly preserved roof

Observations: commerce works
