The Historical Centre of Porto
Building Characterization

Building Characterization

Urban front analysis

The Caldeireiros Street

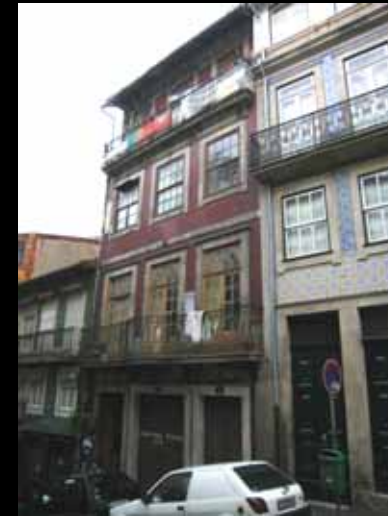
Campo Mártires da Pátria, n.º151, 153, corner with Rua de São Bento da Vitória, 96

Preservation state: **Scanty**, in ruin process

Anomalies: structural sitting and deformation with façade rotation; vertical crevice

Observation: request for reconstruction works (CMP). The top floor proceeds inhabit.

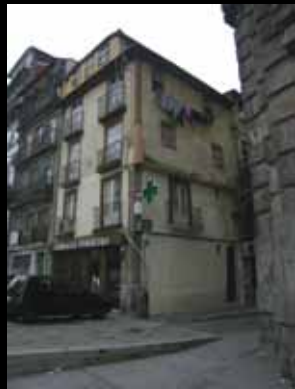
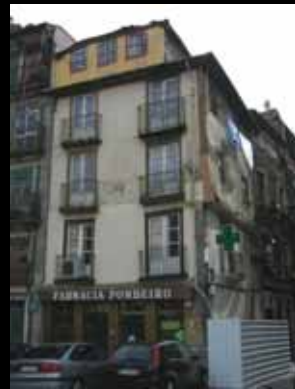
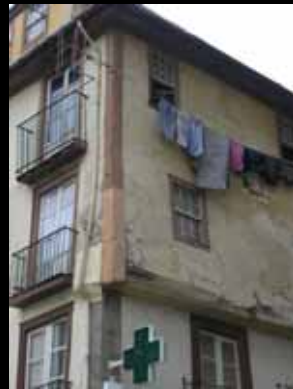
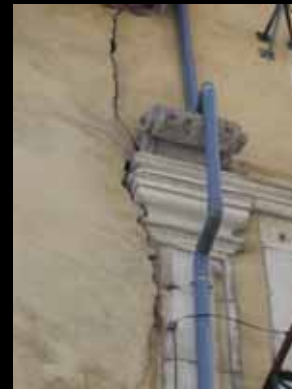
Campo Mártires da Pátria, n.º 148, 149 e 150

Preservation state : **Shallow**

Anomalies : vertical crevice at embrasure in load points; falling tiles and use of strong mortar in the cracks; stone incrustation; badly preserved window-frame

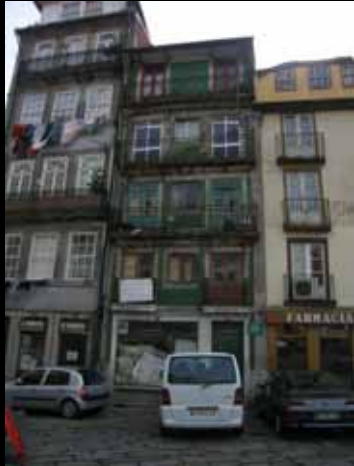
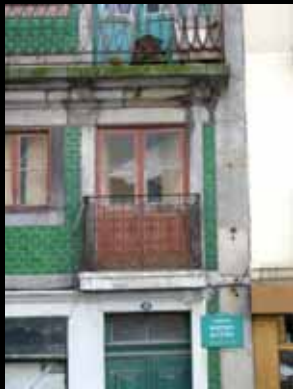
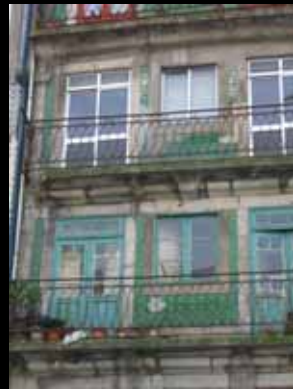
Campo Mártires da Pátria, n.º 145, 146 e 147

Preservation state : **Moderate**

Anomalies: some vertical crevices; open stone joint; stone incrustation

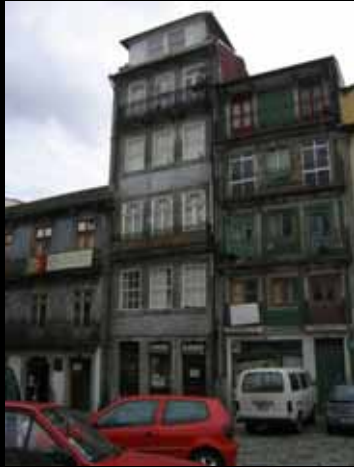
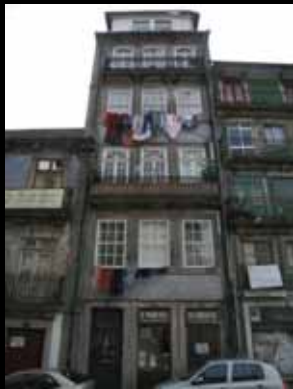
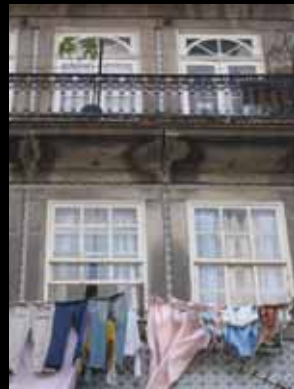
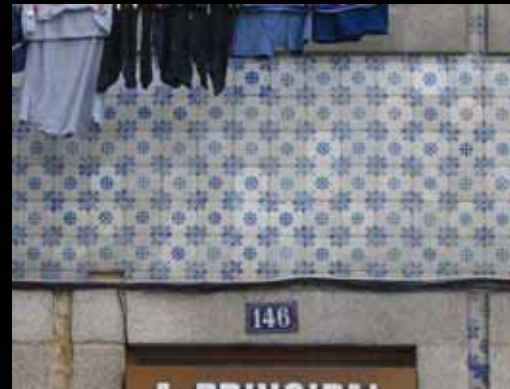
Campo Mártires da Pátria, n.º 143, 144 e 144A

Preservation state : **Shallow**

Anomalies : structural sitting; vertical crevice; structural deformation; vegetable colonization; badly preserved window-frame; reconstruct works in the interior of the ground-floor (XX)

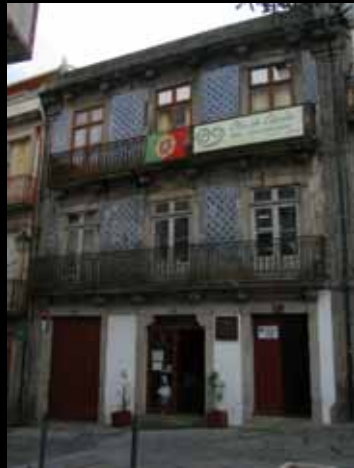
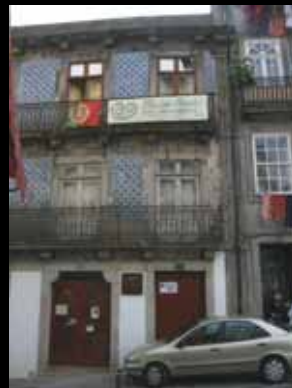
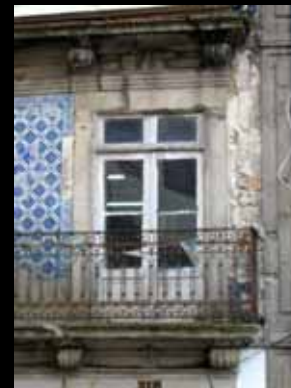
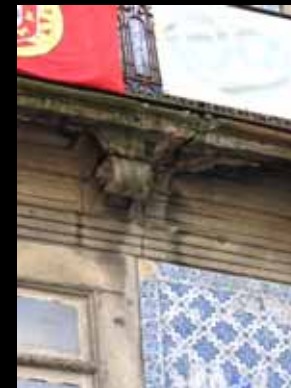
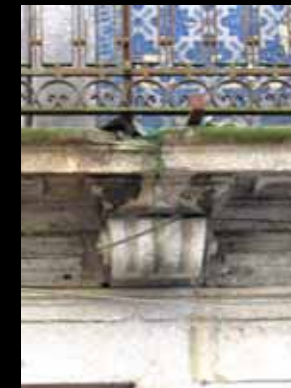
Rua dos Caldeireiros, n.º 265, 263 e 265

Preservation state : **Elevated**

Anomalies : strong mortar; introduction of a new constructive system and materials

Observation : reconstruction works (XXI)

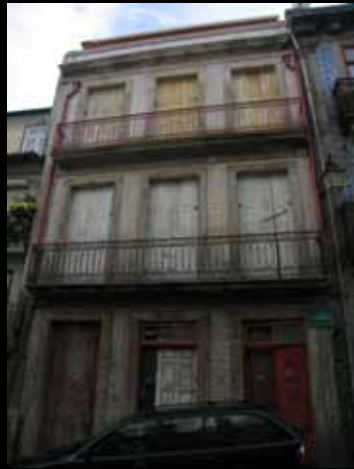
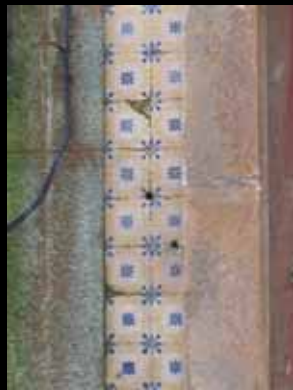
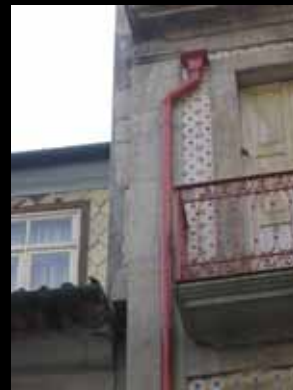
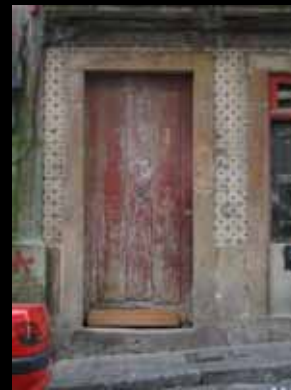
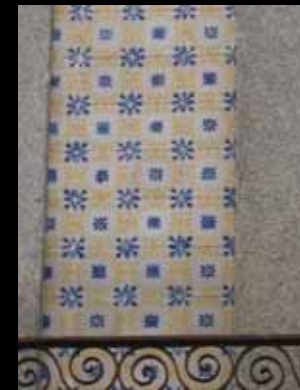
Rua dos Caldeireiros, n.º 257 e 259, gaveto com a Travessa do Ferraz, 41 e 39

Preservation state : **Moderate**

Anomalies : vertical crevice; painted stone; works of preservation with incompatible materials by the original structure

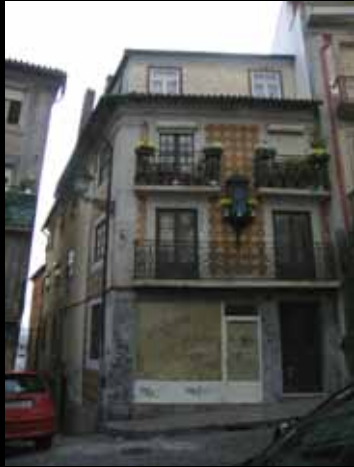
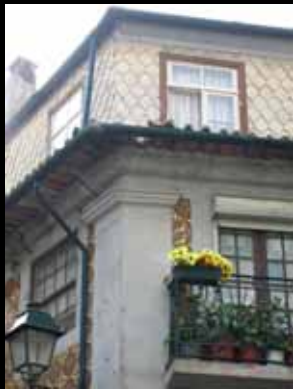
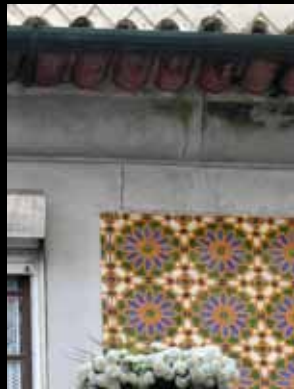
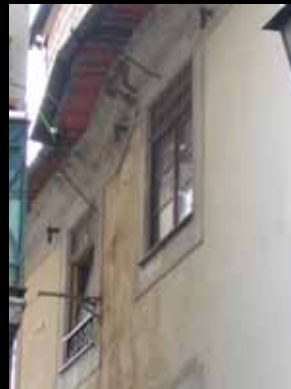
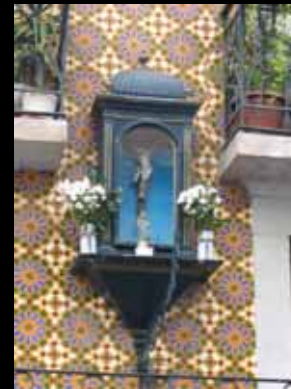
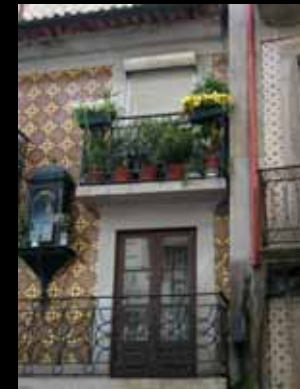
Rua dos Caldeireiros, n.º 251 e 253, gaveto com a Travessa do Ferraz

Preservation state : **Shallow**

Anomalies : stone incrustation; strong mortar; open stone joint; light structural sitting

Observation : “repair” work

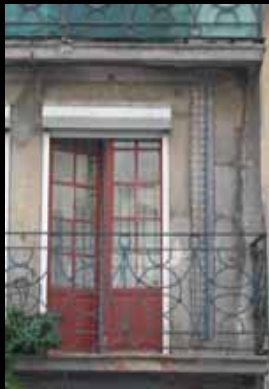
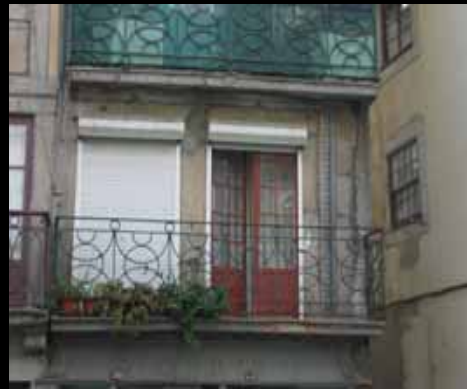
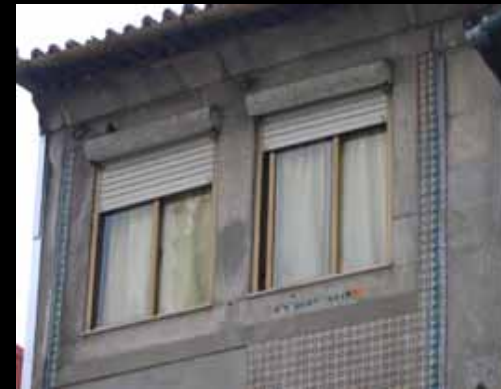
Rua dos Caldeireiros, n.º 247 e 249

Preservation state : **Shallow**

Anomalies : structural sitting and deformation; balcony stone with crevice

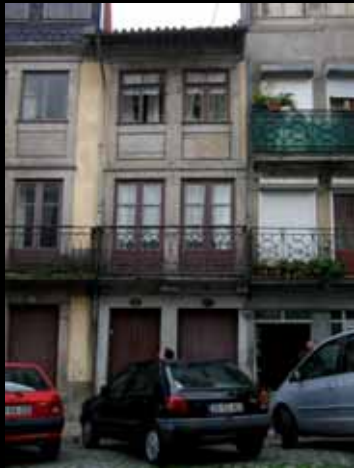
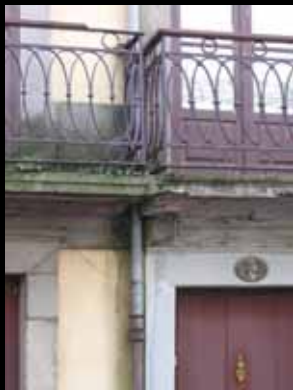
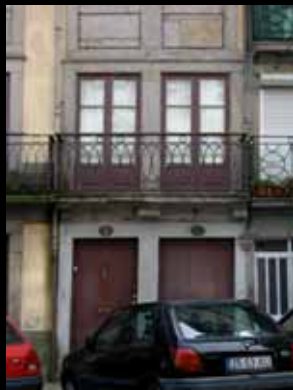
Rua dos Caldeireiros, n.º 243 e 245

Preservation state : **Shallow**

Anomalies : structural deformation on the ground-floor; vegetable colonization; stone incrustation

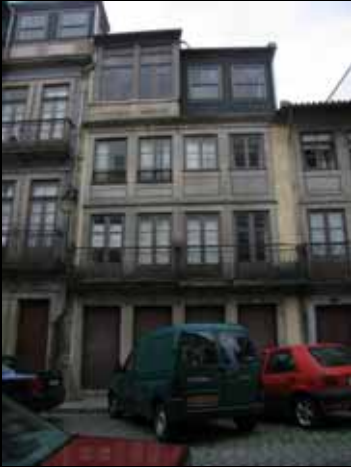
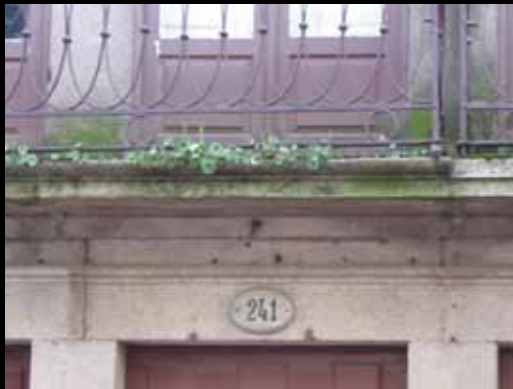
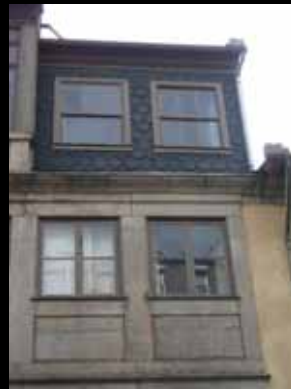
Rua dos Caldeireiros, n.º 239 e 241

Preservation state : **Shallow**

Anomalies: some structural deformation on the ground-floor; vegetable colonization; stone incrustation

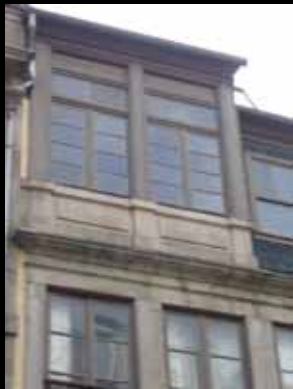
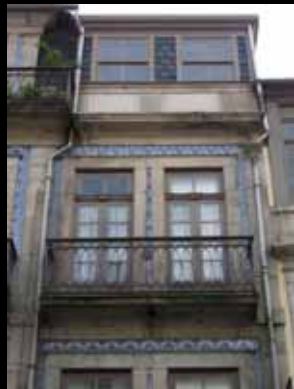
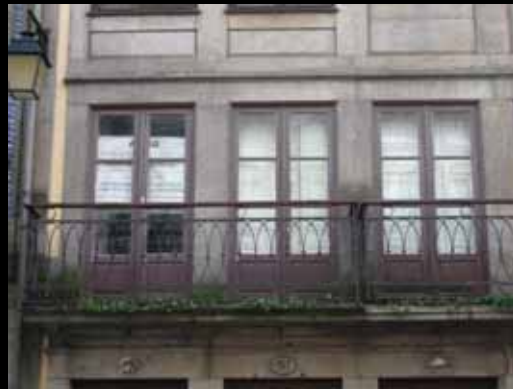
Rua dos Caldeireiros, n.º 237 e 239

Preservation state : **Moderate**

Anomalies: stone incrustation

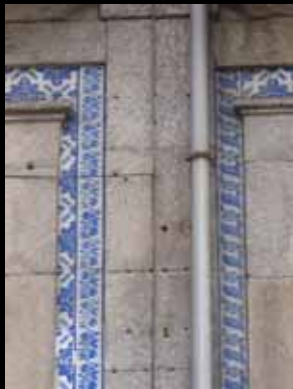
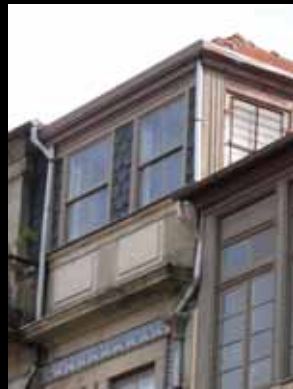
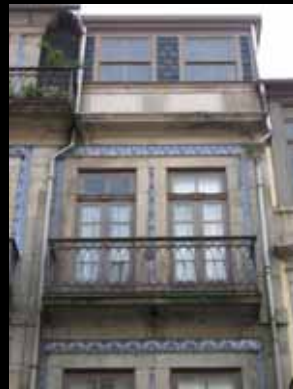
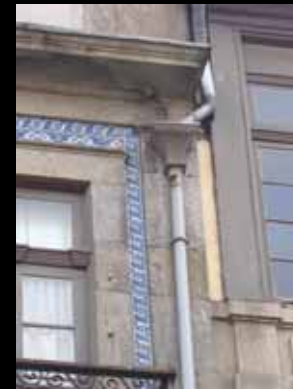
Rua dos Caldeireiros, n.º 231, 233 e 235

Preservation state : **Moderate**

Anomalies: stone incrustation; badly preserved wood window-frames

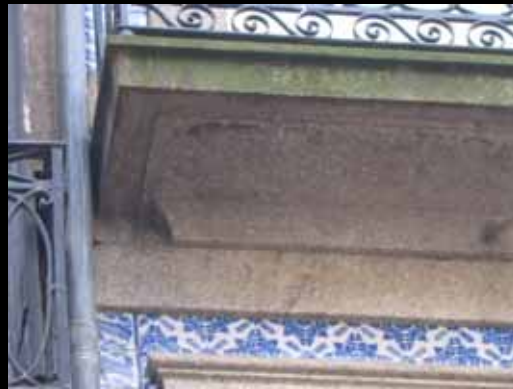
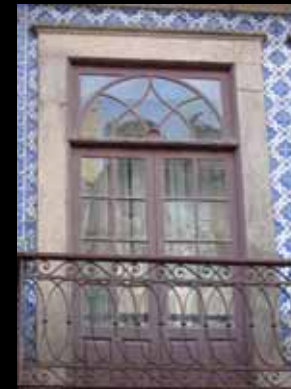
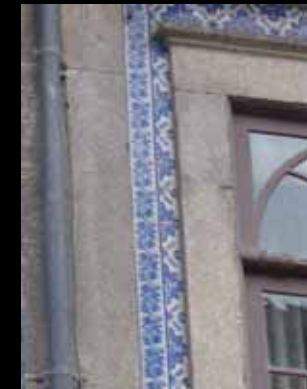
Rua dos Caldeireiros, n.º 227 e 229

Preservation state: **Elevated**

Anomalies: stone incrustation

Observation : reconstruction works

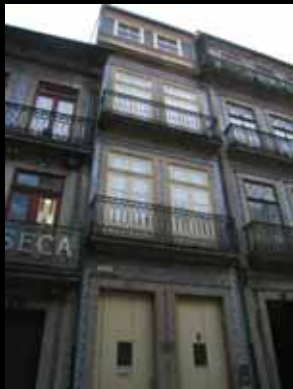
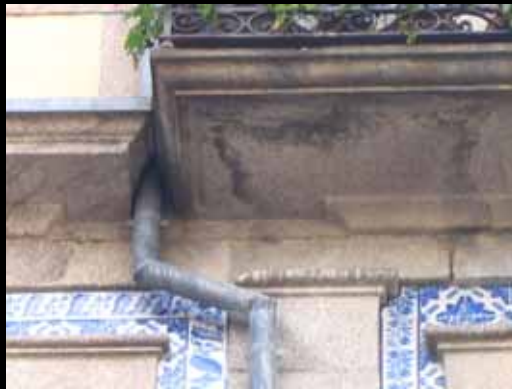
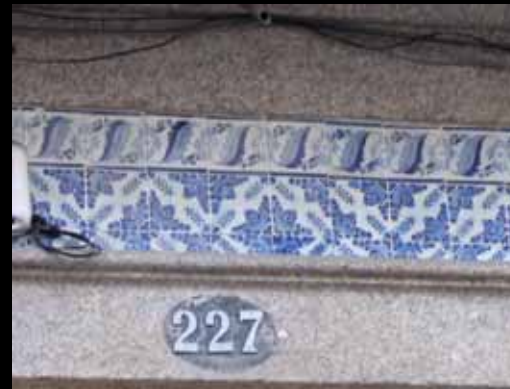
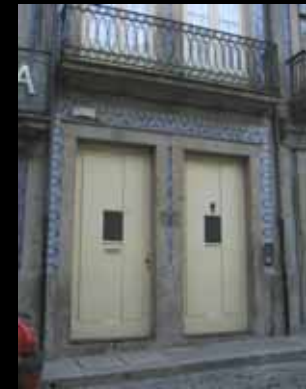
Rua dos Caldeireiros, n.º 225, 225A e 225B

Preservation state: **Moderate**

Anomalies: stone incrustation; light structure deformation

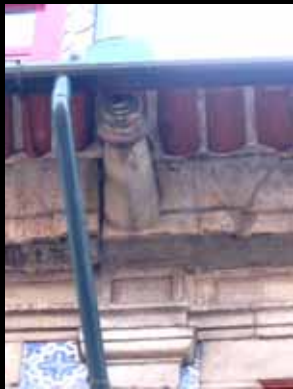
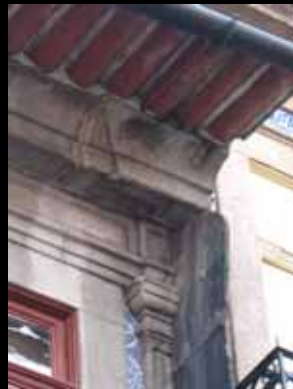
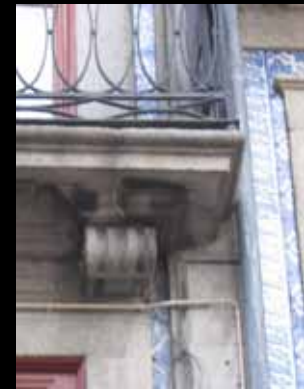
Rua dos Caldeireiros, n.º 221 e 223

Preservation state: **Elevated**

Observation: reconstruction works

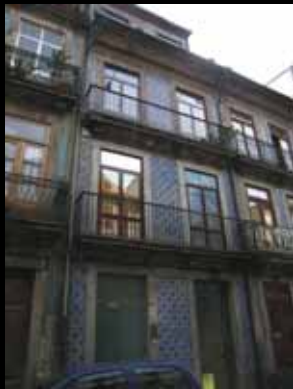
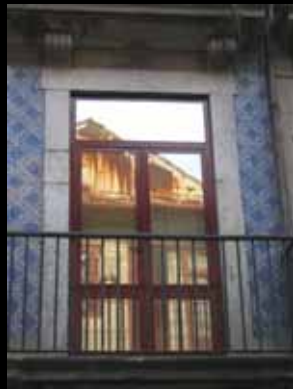
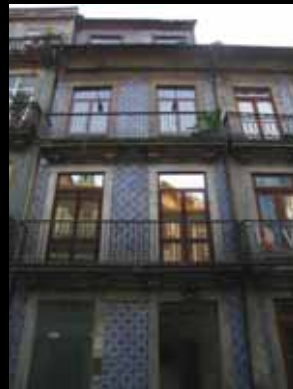
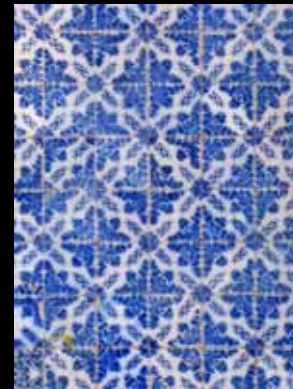
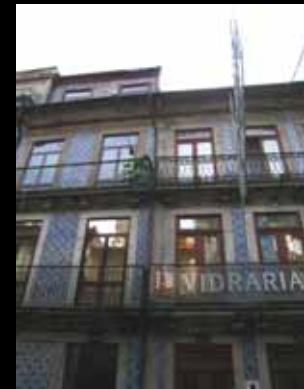
Rua dos Caldeireiros, n.º 217A e 219

Preservation state: **Scanty**

Anomalies: vertical crevice; falling tiles; stone incrustation; moss; granular disintegration

Observation: degradation process

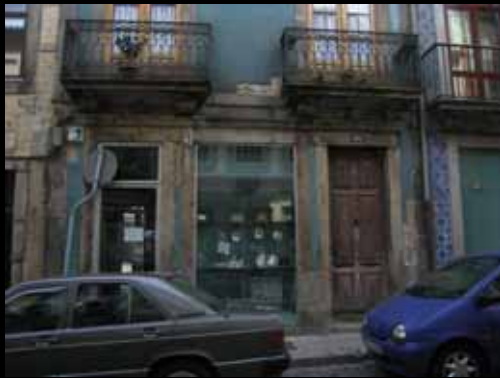
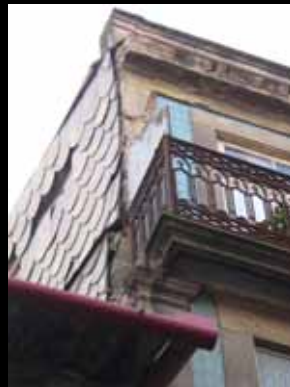
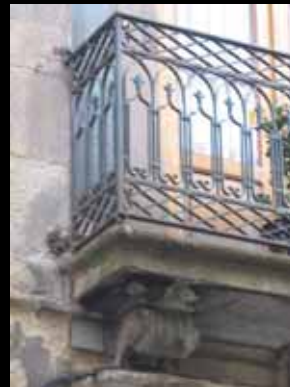
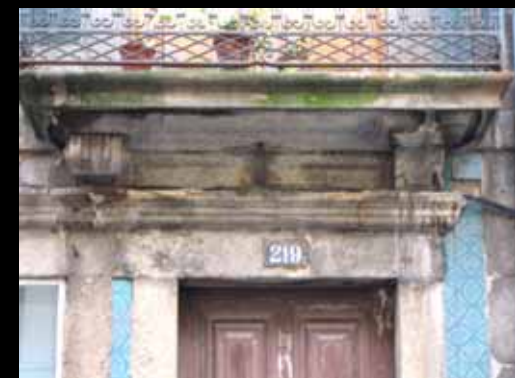
Rua dos Caldeireiros, n.º 215 e 217

Preservation state: **Moderate**

Anomalies: falling tiles; strong mortar at stone joints

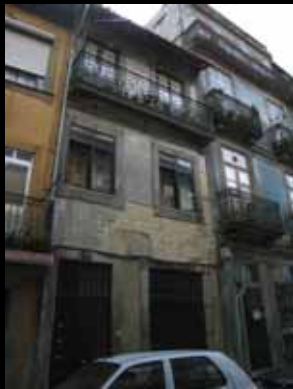
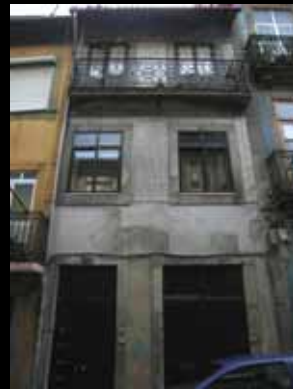
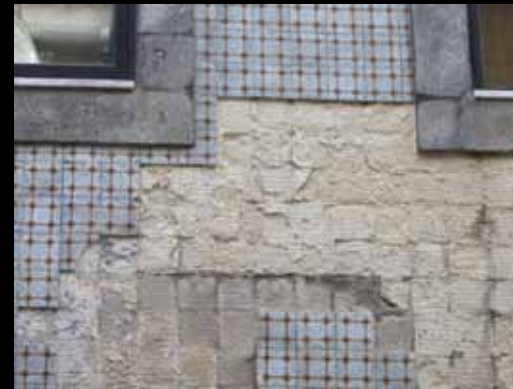
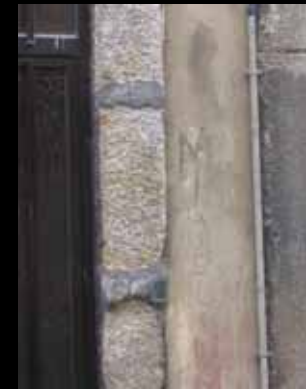
Rua dos Caldeireiros, n.º 211 e 213

Conservation state: **Shallow**

Anomalies: vertical crevice; paint rise up in blisters; humidity stains; new materials introduction

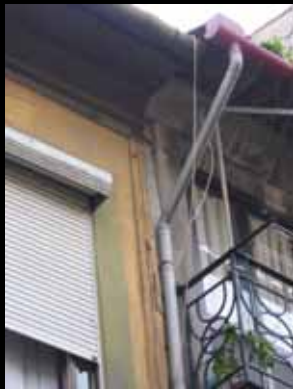
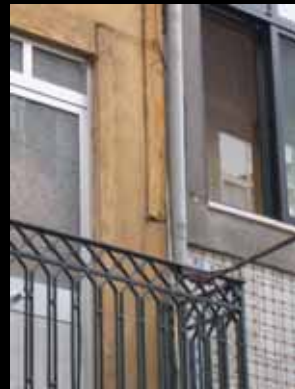
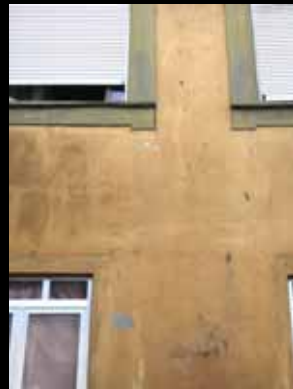
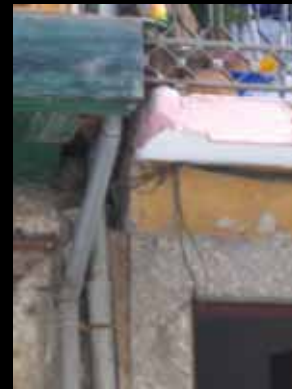
Rua dos Caldeireiros, n.º 207 e 209

Preservation state: **Scanty**, in ruin process

Anomalies: structural decay; structural sitting with vertical crevice; wood putrefaction

Observation: total structural decay (2006). It was interdicted in 2007.

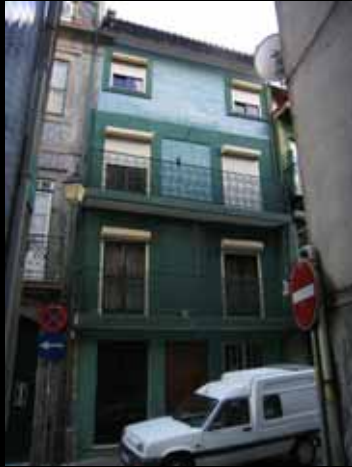
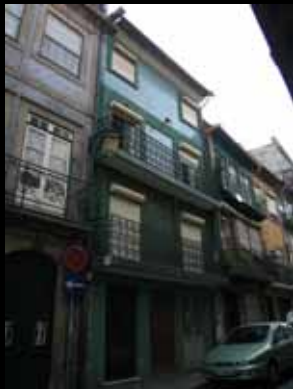
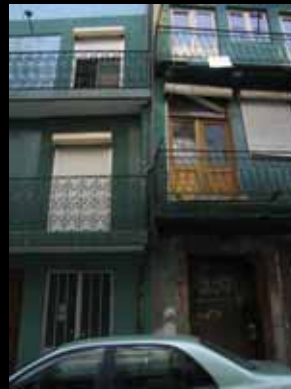
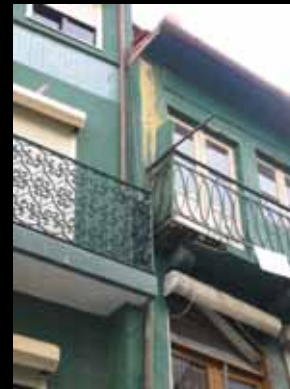
Rua dos Caldeireiros, n.º 201, 203 e 205

Preservation state: **Moderate**

Anomalies: new structural system

Observation: reconstructed building

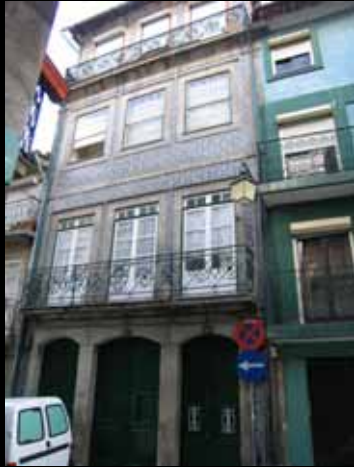
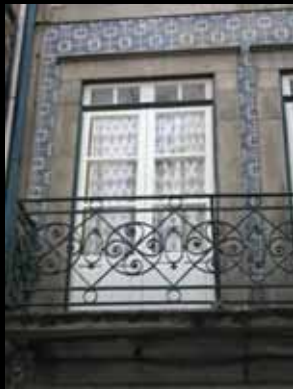
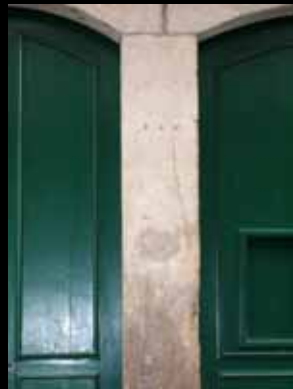
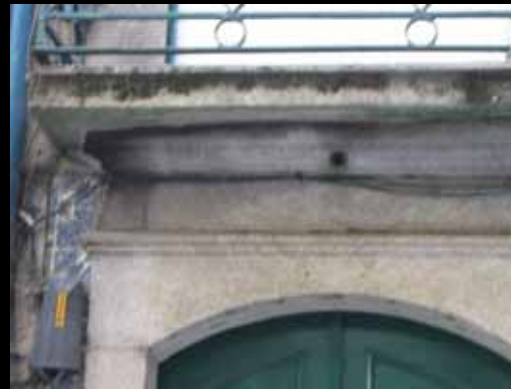
Rua dos Caldeireiros, n.º 195, 197 e 199

Preservation state : **Elevated**

Anomalies: stone incrustation, vegetable colonization

Observation: reconstruction work

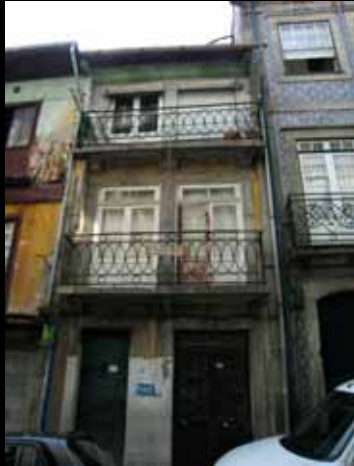
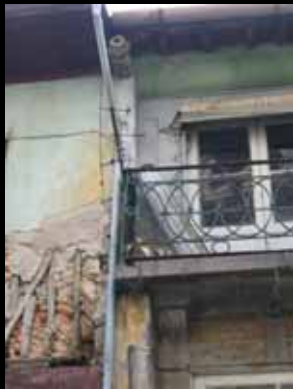
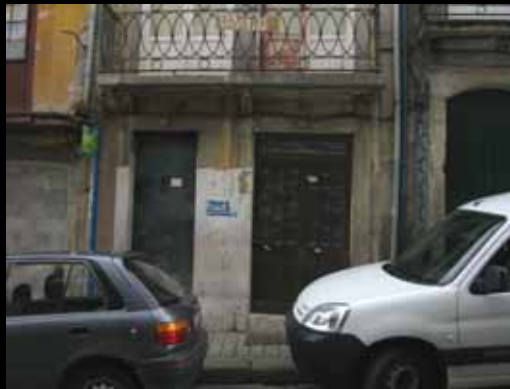
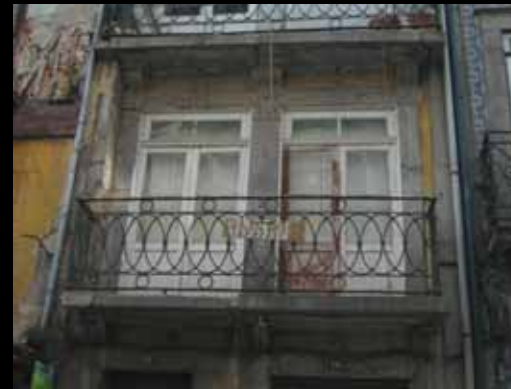
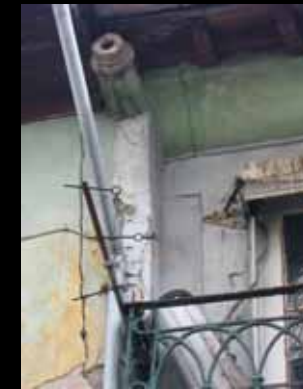
Rua dos Caldeireiros, n.º 191 e 193

Preservation state: **Scanty**

Anomalies: vertical crevice; stone incrustation; strong mortar in the stone joints

Observation: structural decay

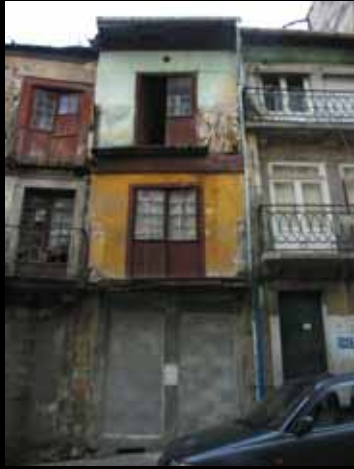
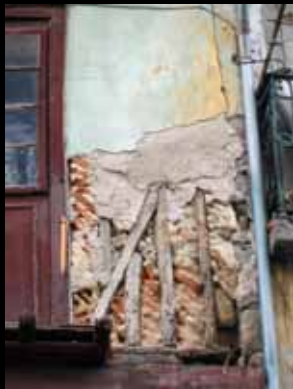
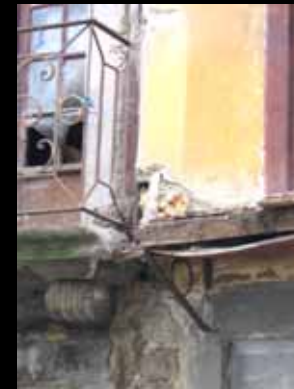
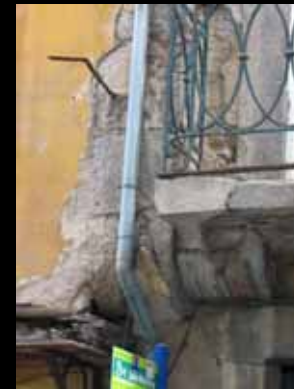
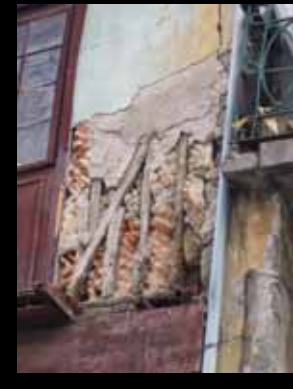
Rua dos Caldeireiros, n.º 187 e 189

Preservation state: **Scanty**, in ruin process

Anomalies: total structural decay

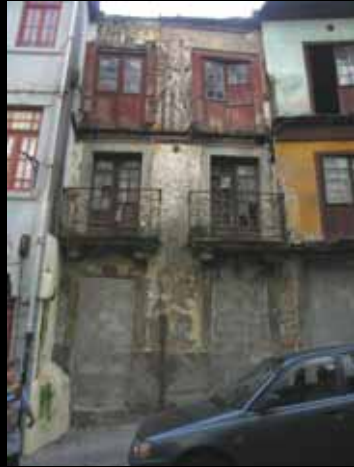
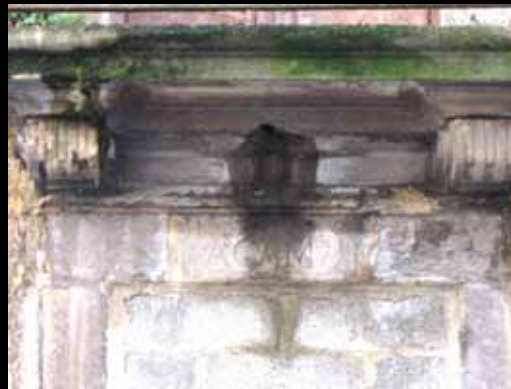
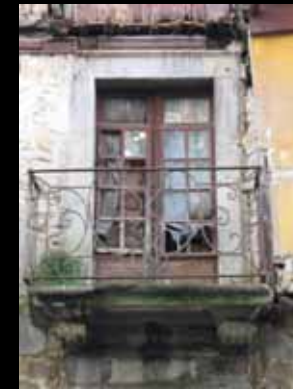
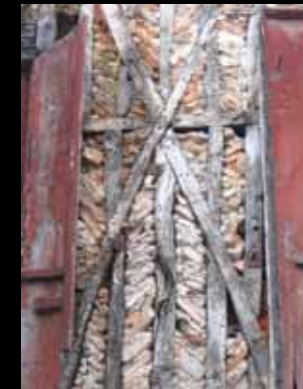
Rua dos Caldeireiros, n.º 183 e 185

Preservation state: **Scanty**, in ruin process

Anomalies: total structure decay; vertical crevice; wood putrefaction; vegetable colonization; stone incrustation

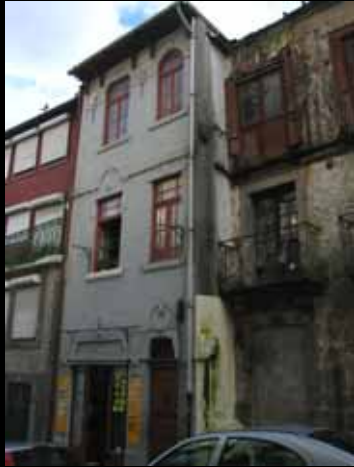
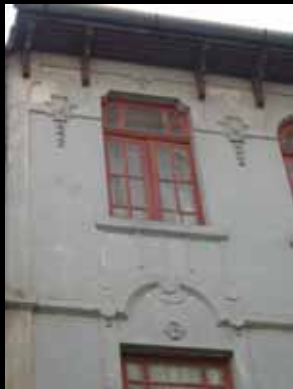
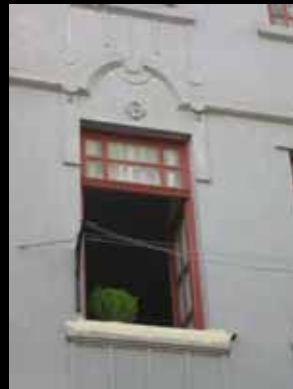
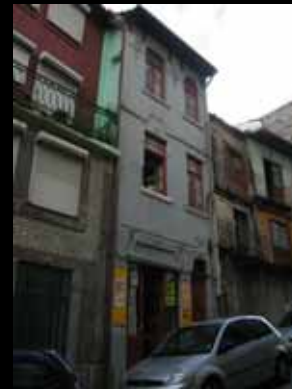
Rua dos Caldeireiros, n.º 181 e 181A

Preservation state: **Moderate**

Anomalies: ink rise up in blisters; humidity stains

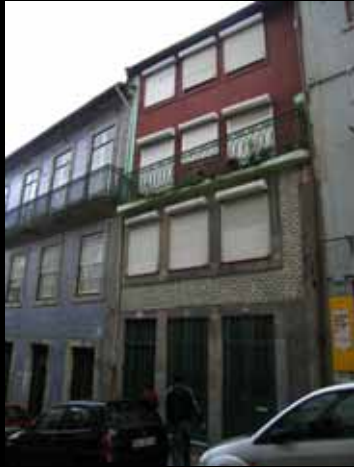
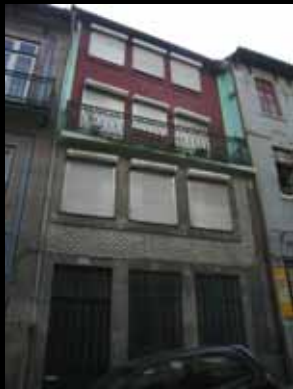
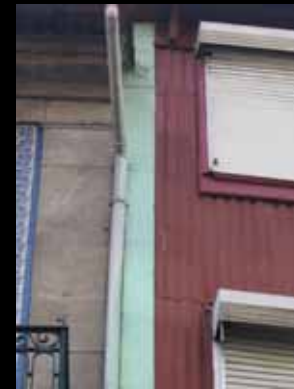
Rua dos Caldeireiros, n.º 175, 177 e 179

Preservation state: **Moderate**

Anomalies: vegetable colonization; strong mortar; blisters

Observations: reconstruction work

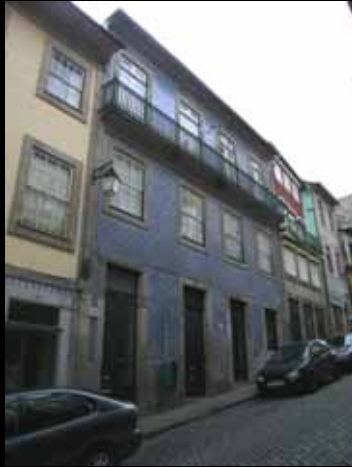
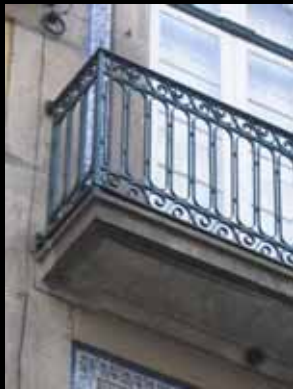
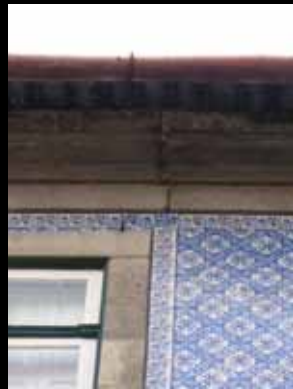
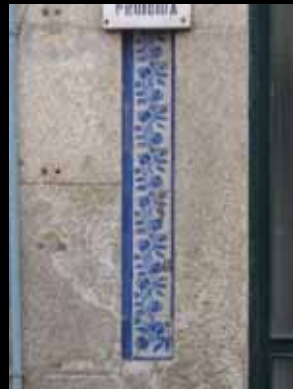
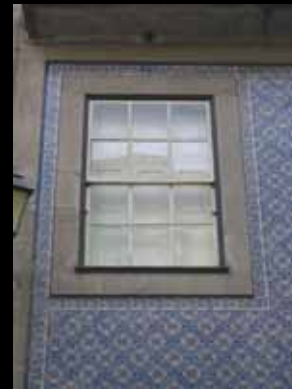
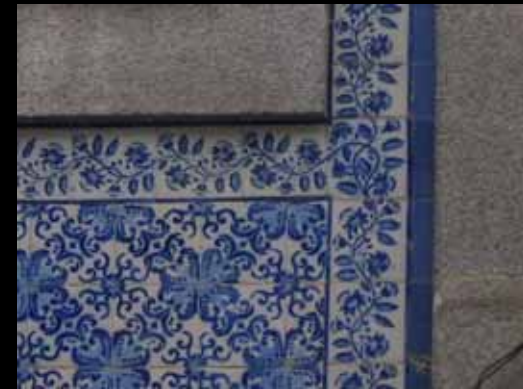
Rua dos Caldeireiros, n.º 167, 169, 171 e 173

Preservation state: **Elevated**

Anomalies: vegetable colonization

Observation: reconstruction work

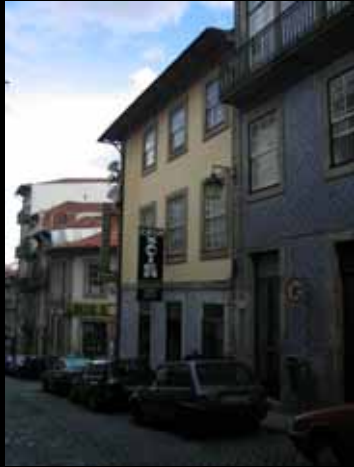
Rua dos Caldeireiros, n.º 161, 163 e 165, gaveto com a Rua da Vitória

Preservation state: **Elevated**

Anomalies: ink rise up in blisters

Observations: reconstruction work

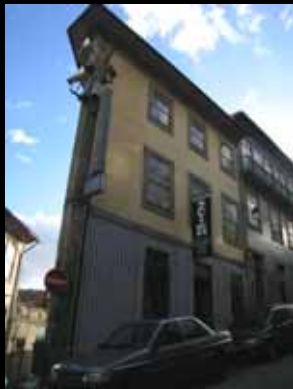
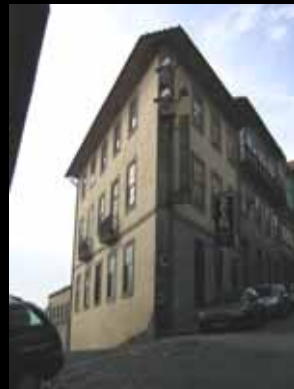
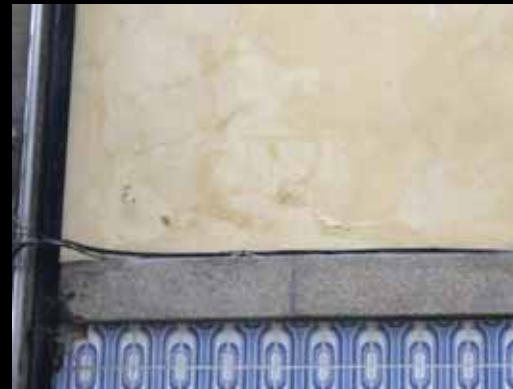
Rua dos Caldeireiros, gaveto com a Rua da Vitória, n.º 1 e 5

Preservation state: **Shallow**

Anomalies: vertical crevice; cracks in the rough-cast; vegetable colonization

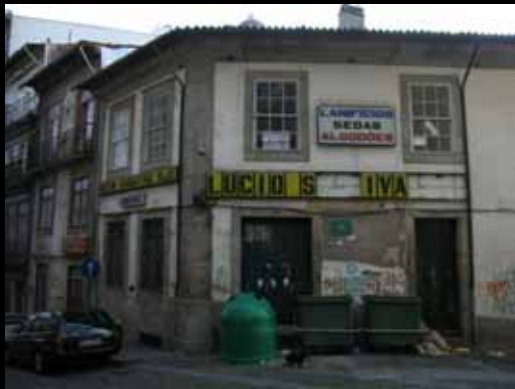
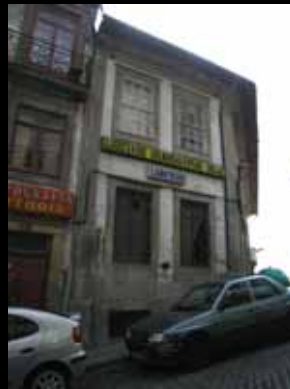
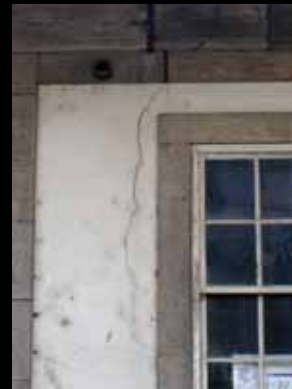
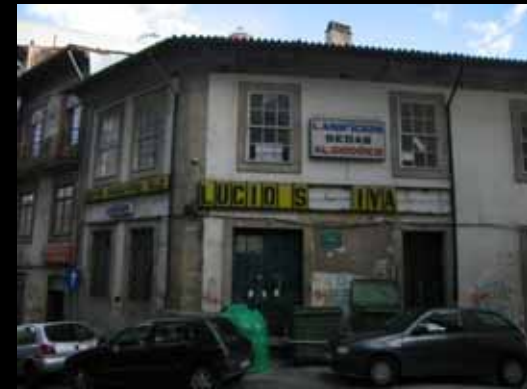
Rua dos Caldeireiros, n.º 153 e 155

Preservation state: **Shallow**

Anomalies: cracks and rise up in blister of the rough-cast; crevices; stone incrustation

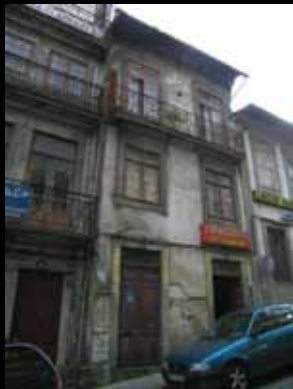
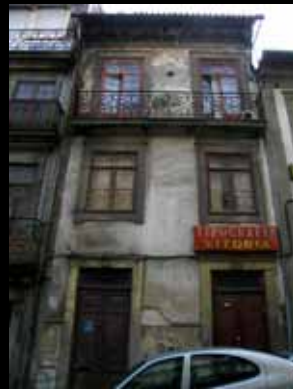
Rua dos Caldeireiros, n.º 147, 149 e 151

Preservation state: **Shallow**

Anomalies: light structural sitting and deformation; vegetable colonization and stone incrustation; light granular disintegration; badly preserved window-frame; tiles crevice

Observation: decay process

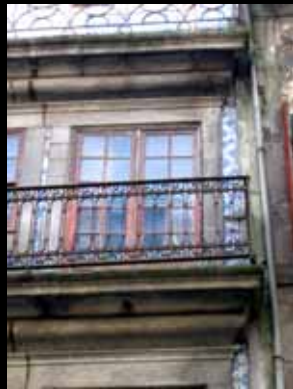
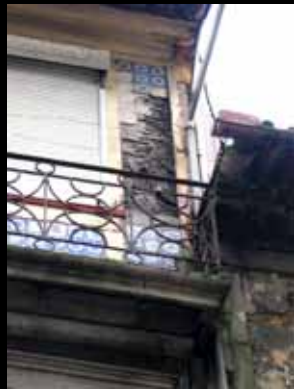
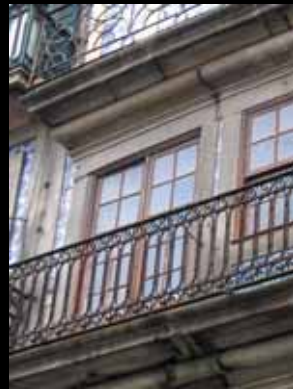
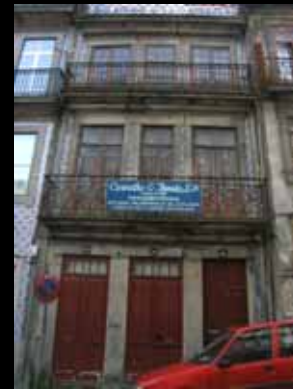
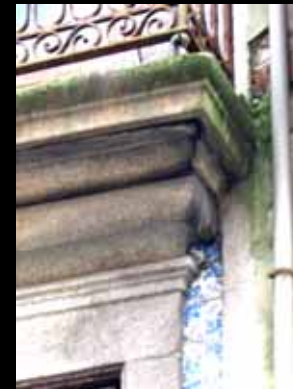
Rua dos Caldeireiros, n.º 143 e 145

Preservation state: **Moderate**

Anomalies: light stone incrustation

Observation: reconstruction work

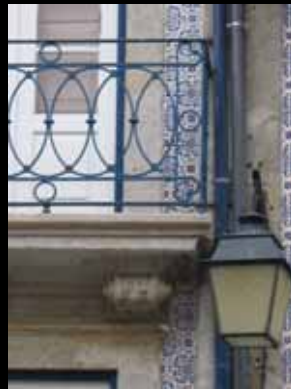
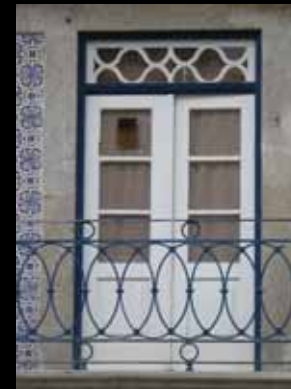
Rua dos Caldeireiros, n.º 131, 133 e 135

Preservation state: **Scant**

Anomalies: structural decay; vertical crevices; sitting foundation; vegetable colonization; stone incrustation; badly preserved window-frames

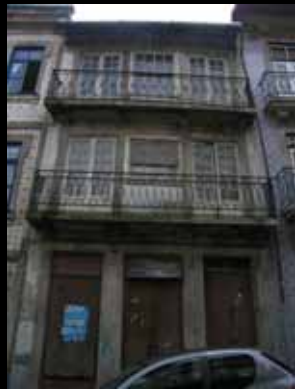
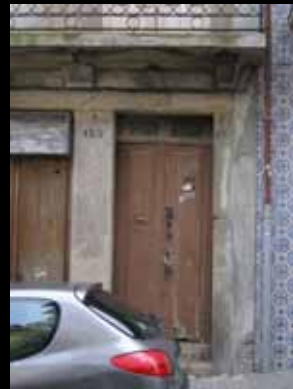
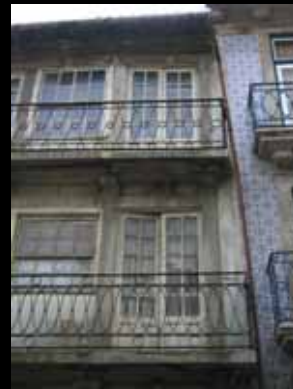
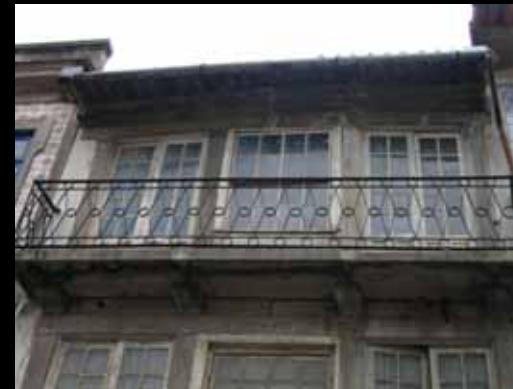
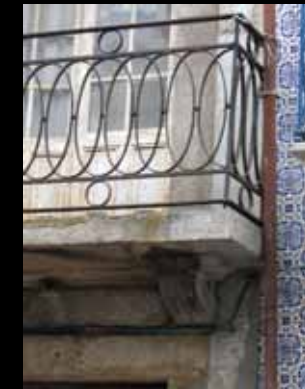
Rua dos Caldeireiros, n.º 125, 127 e 129

Preservation state: **Moderate**

Anomalies: stone incrustation

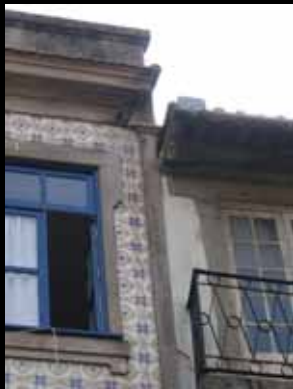
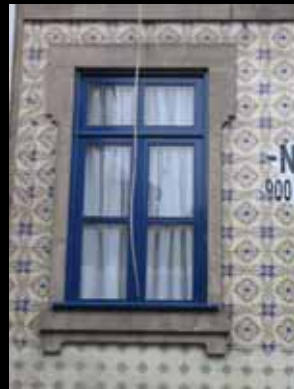
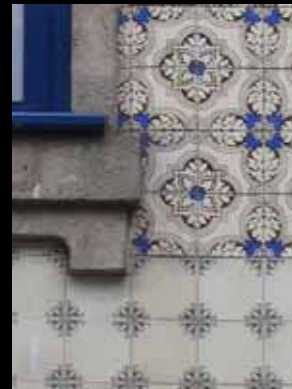
Rua dos Caldeireiros, n.º 119, 121 e 123

Preservation state: **Moderate**

Anomalies: stone incrustation; crevice

Observation: new internal structure

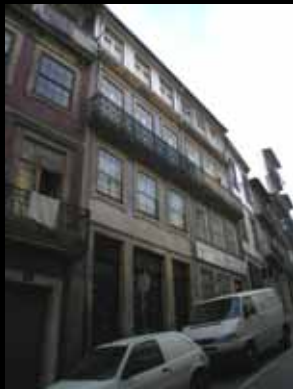
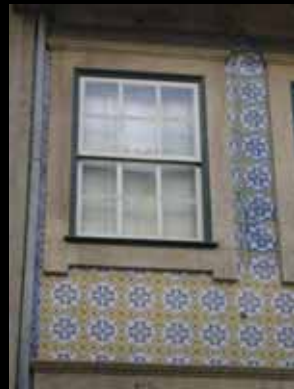
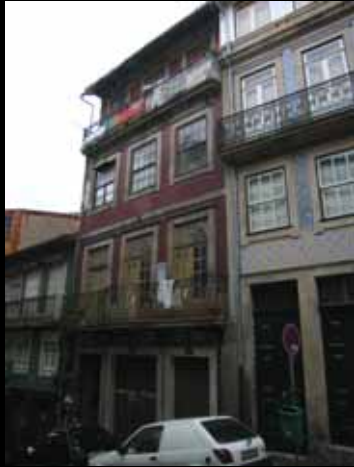
Rua dos Caldeireiros, n.º 107, 109 e 111

Preservation state: **Shallow**

Anomalies: vertical crevice; open stone joint; badly preserved interior;
stone incrustation; falling tiles; badly preserved window-
frame; broken glass

Observation: structural decay

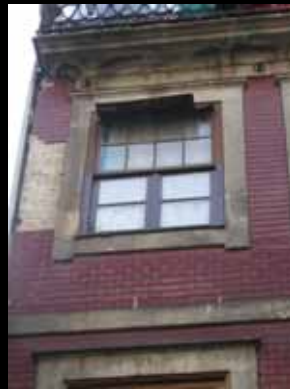
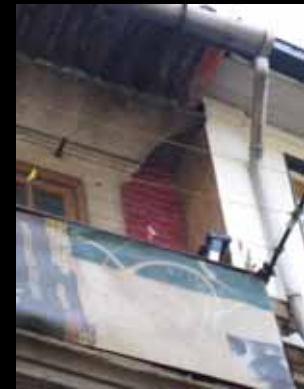
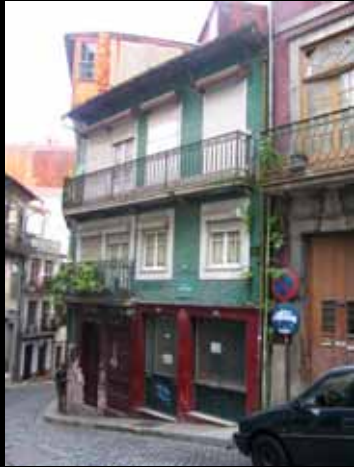
Rua dos Caldeireiros, n.º 103 e 105

Preservation state: **Shallow**

Anomalies: structural deformation; vegetable colonization; stone
incrustation; wood putrefaction; tiles rise up; painted stone

Observation: decay process

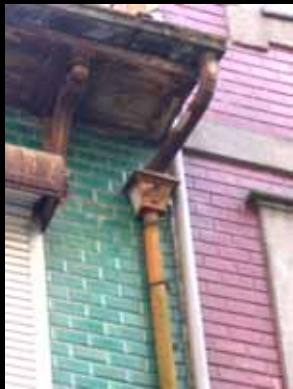
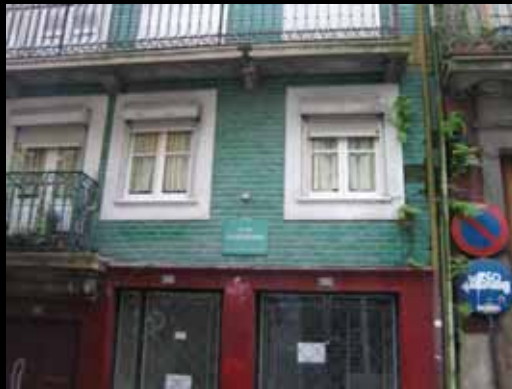
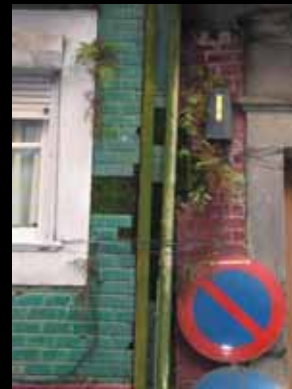
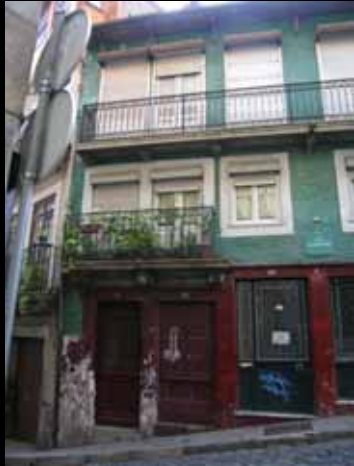
Rua dos Caldeireiros, n.º 99 e 101

Preservation state: **Shallow**

Anomalies: structural deformation; vegetable colonization; wood putrefaction; tiles rise up; painted stone; granular disintegration

Observation: decay process

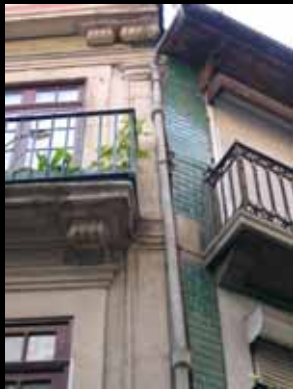
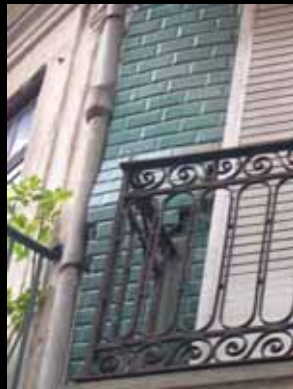
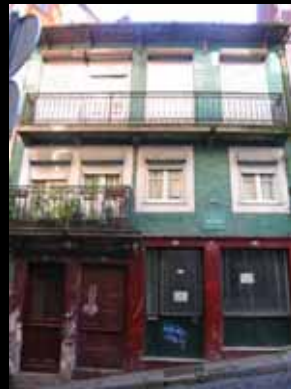
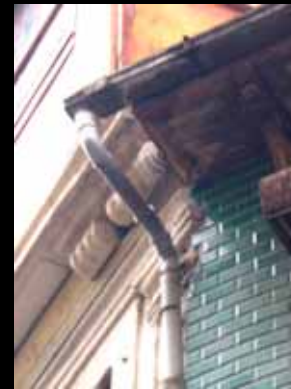
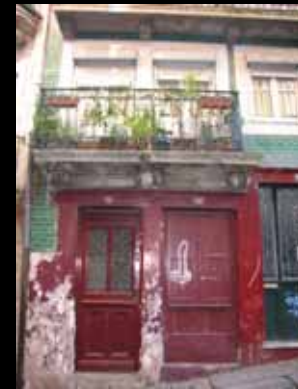
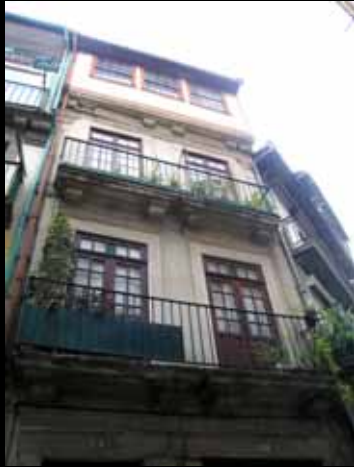
Rua dos Caldeireiros, n.º 95 e 97

Preservation state: **Shallow**

Anomalies: lost of horizontality in the structural elements; vertical crevice; granular disintegration; stone incrustation

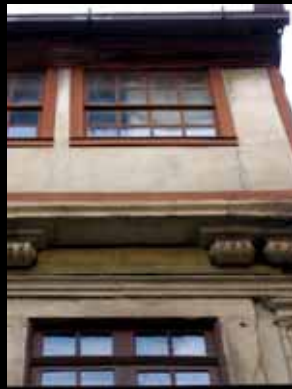
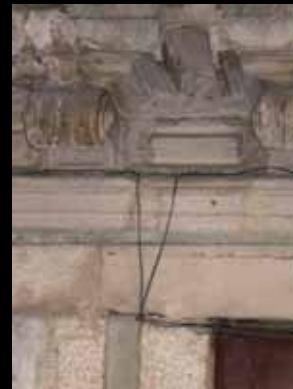
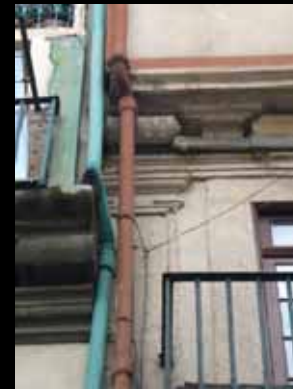
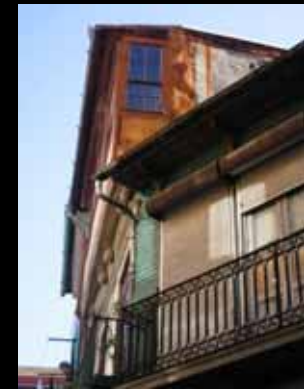
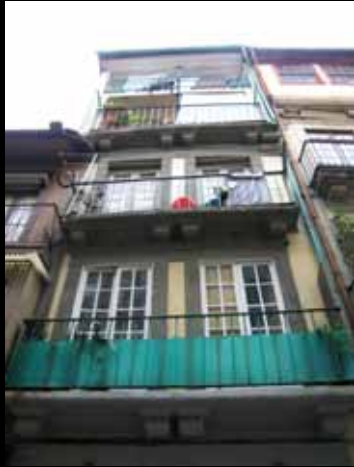
Rua dos Caldeireiros, n.º 91 e 93

Preservation state: **Shallow**

Anomalies: structural deformation; crevice

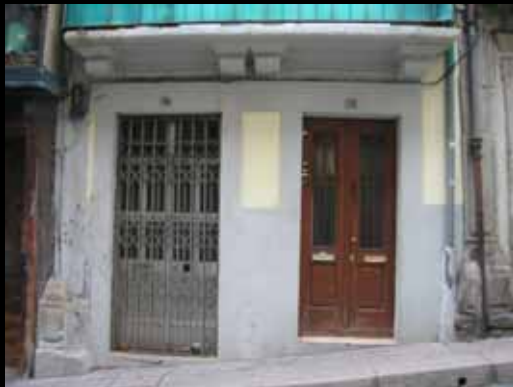
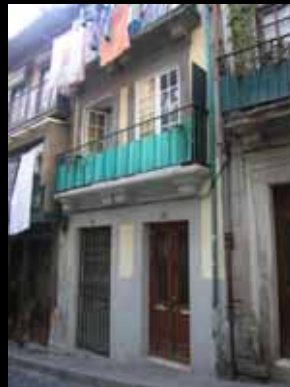
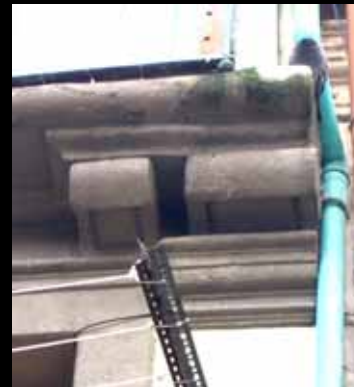
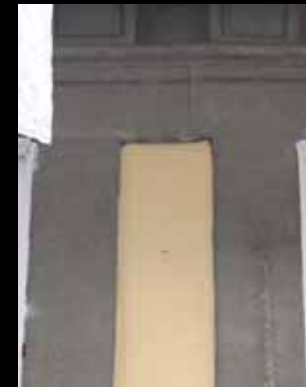
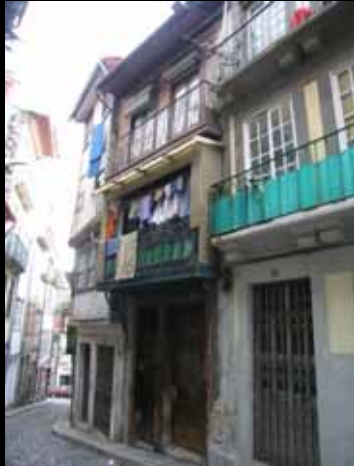
Rua dos Caldeireiros, n.º 87 e 89

Preservation state: **Scanty**

Anomalies: structural deformation; vertical crevice; wood putrefaction

Observation: structural decay
