The Historical Centre of Porto
Building Characterization

Building Characterization

Urban front analysis

The Caldeireiros Street

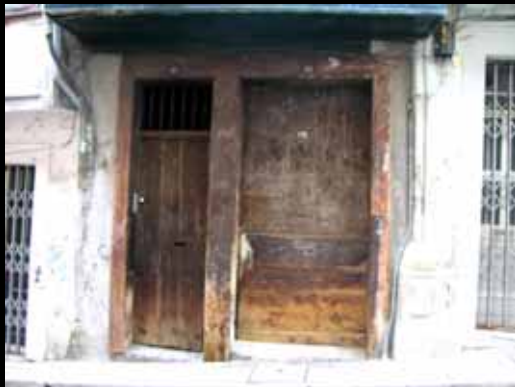
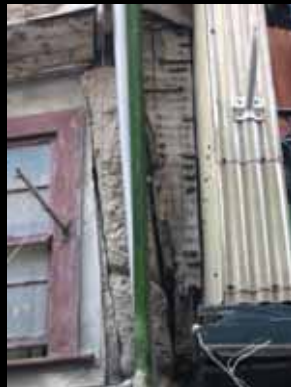
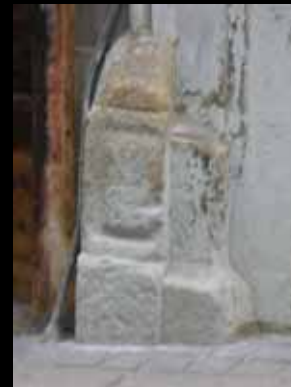
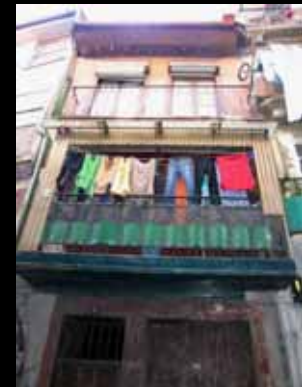
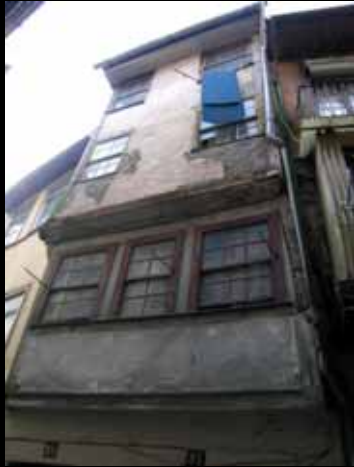
Rua dos Caldeireiros, n.º 83 e 85

Preservation state: **Scanty**

Anomalies: structural deformation; strong mortar; badly preserved window-frames

Observation: total structural decay

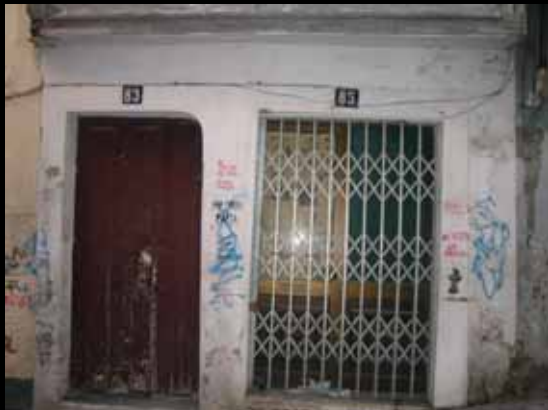
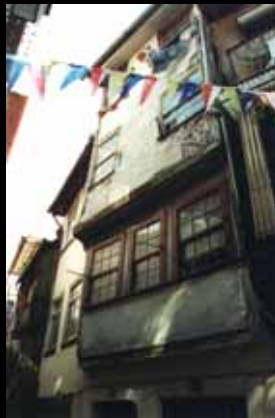
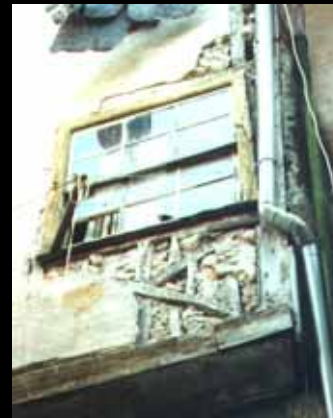
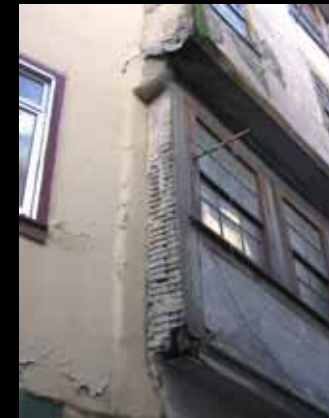
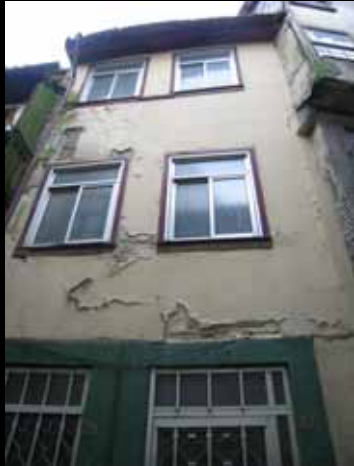
Rua dos Caldeireiros, n.º 79 e 81

Preservation state: **Shallow**

Anomalies: badly preservation state

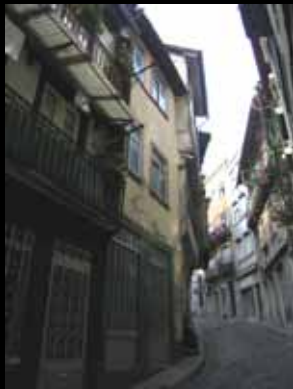
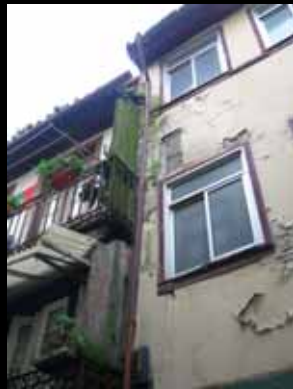
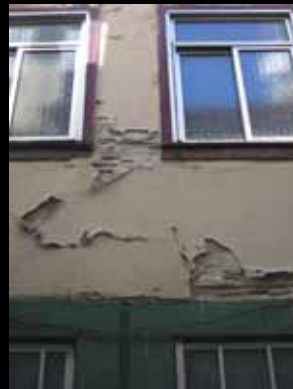
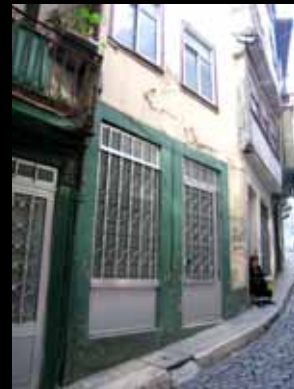
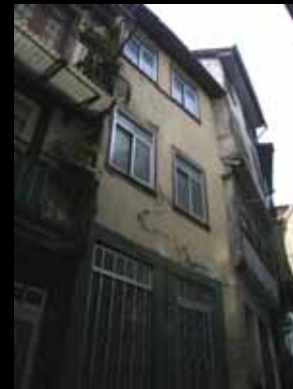
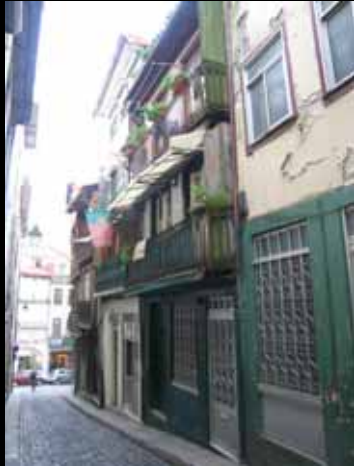
Rua dos Caldeireiros, n.º 75 e 77

Preservation state: **Scanty**

Anomalies: lost of horizontality in the structural elements; vertical crevice; vegetable colonization; wood putrefaction

Observation: structural decay

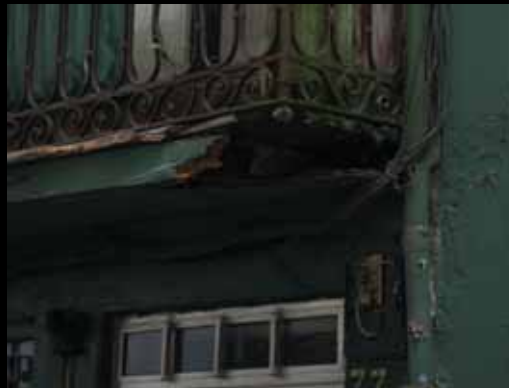
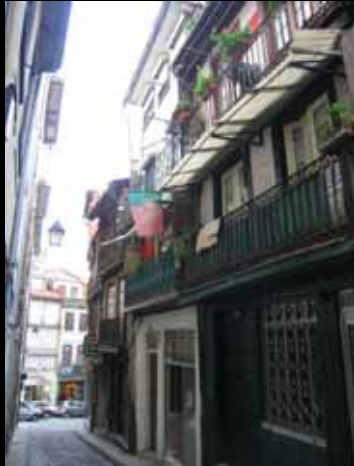
Rua dos Caldeireiros, n.º 73 e 71

Preservation state: **Shallow**

Anomalies: lost of horizontality in the structural elements; wood
putrefaction

Observation: structural decay

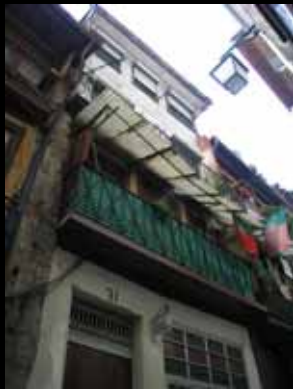
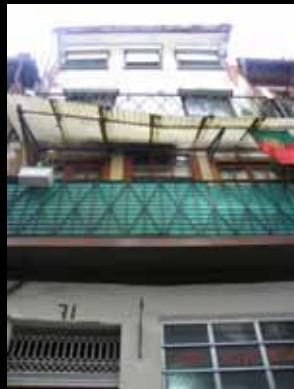
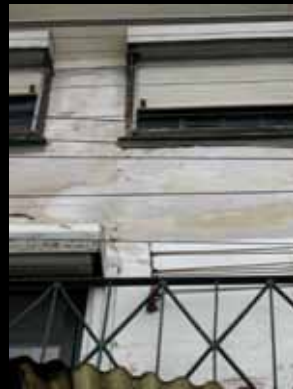
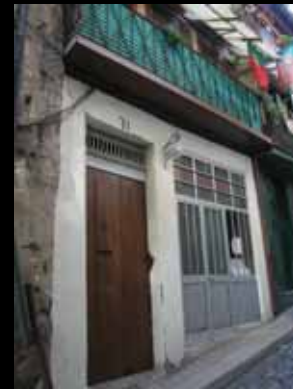
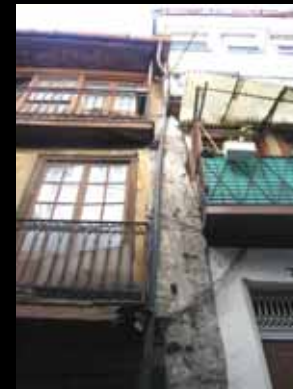
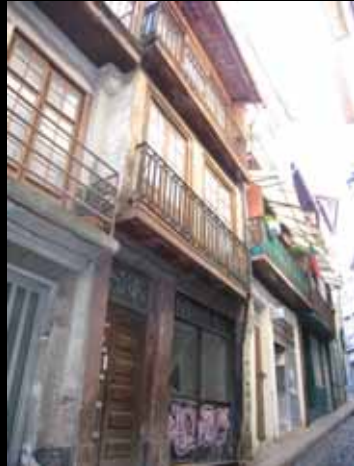
Rua dos Caldeireiros, n.º 67 e 69

Preservation state: **Scanty**

Anomalies: lost of horizontality and verticality in the structural elements; badly preserved window-frames; wood putrefaction; rough-cast rise up

Observations: structural decay

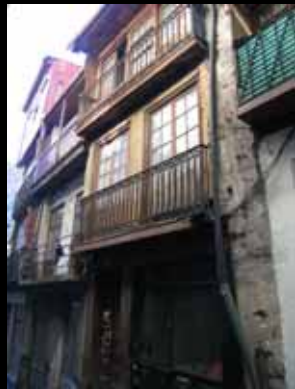
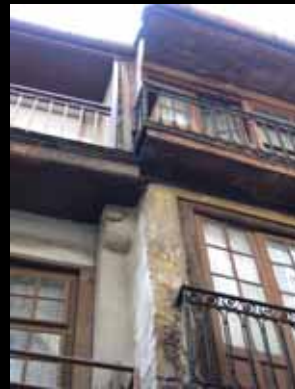
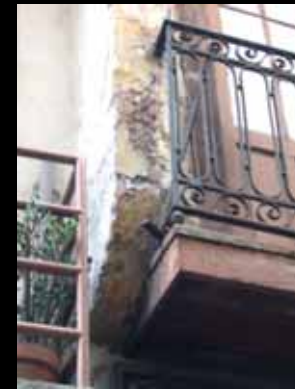
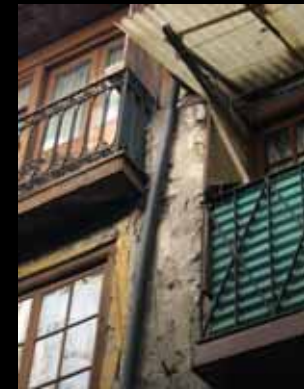
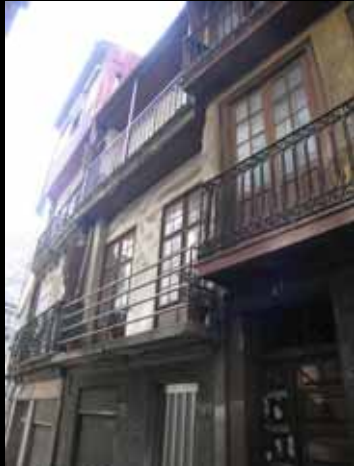
Rua dos Caldeireiros, n.º 63 e 65

Preservation state: **Shallow**

Anomalies: wood putrefaction; stone incrustation; new materials and structure

Observation: structural decay

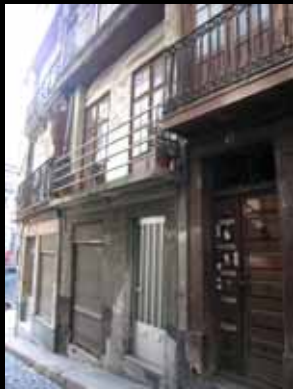
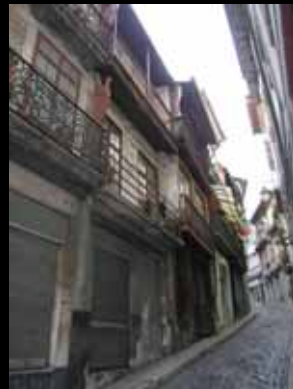
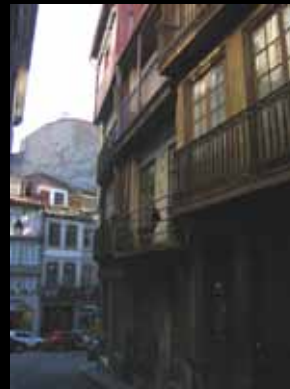
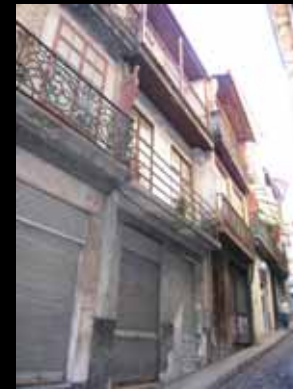
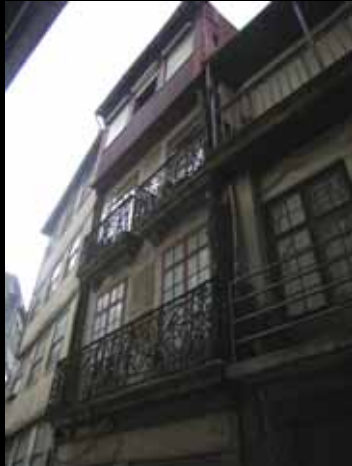
Rua dos Caldeireiros, n.º 59 e 61

Preservation state: **Shallow**

Anomalies: stone incrustation; tiles rise up; granular disintegration; open joint

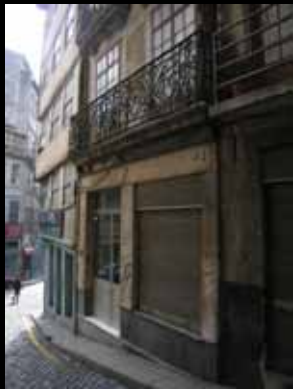
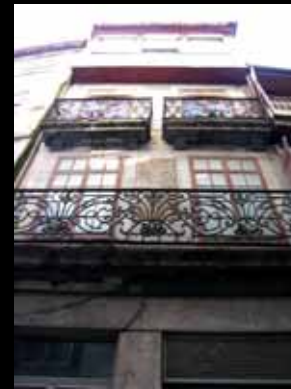
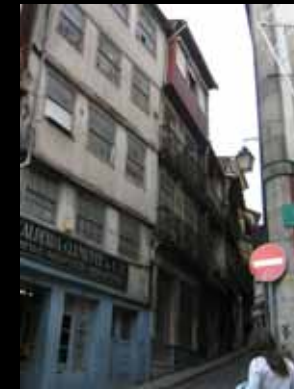
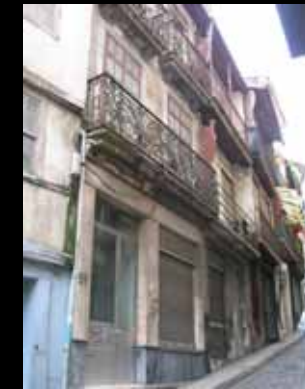
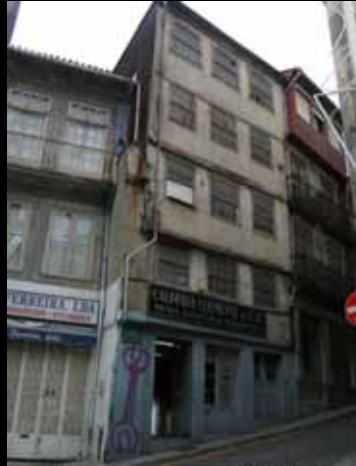
Rua dos Caldeireiros, n.º 53, 55 e 59

Preservation state: **Scanty**

Anomalies: structural deformation; vertical crevice with façade
displacement

Observation: total structural decay

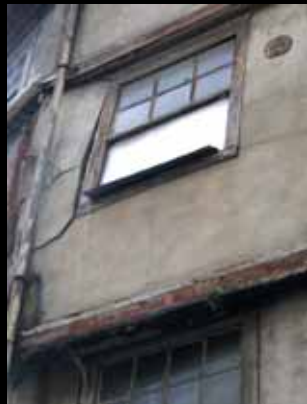
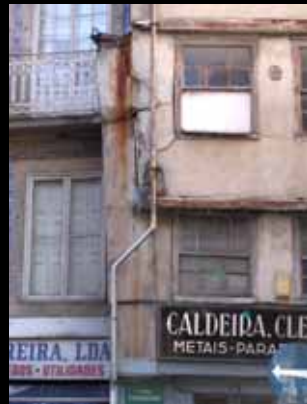
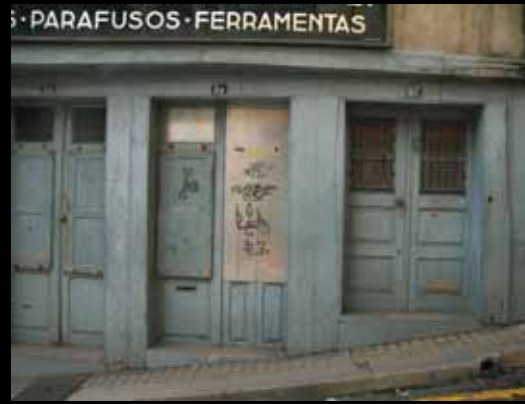
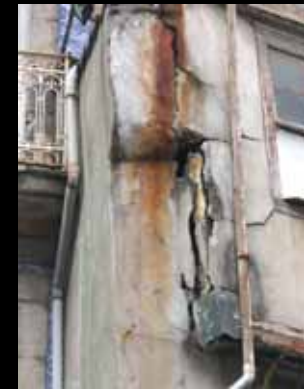
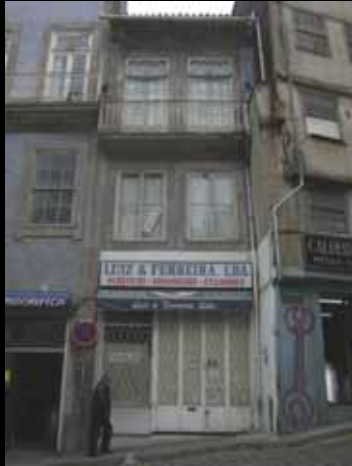
Rua dos Caldeireiros, n.º 49 e 51

Preservation state: **Moderate**

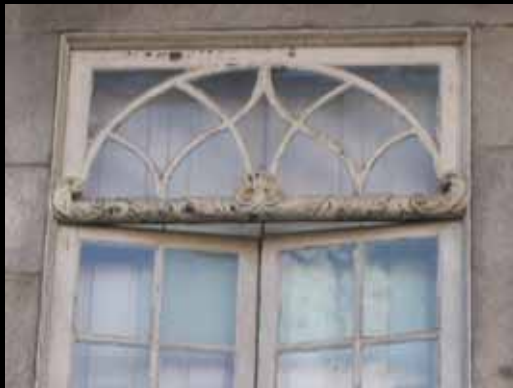
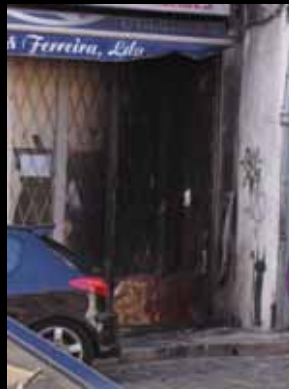
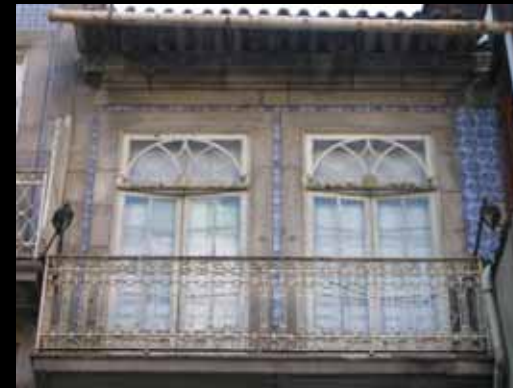
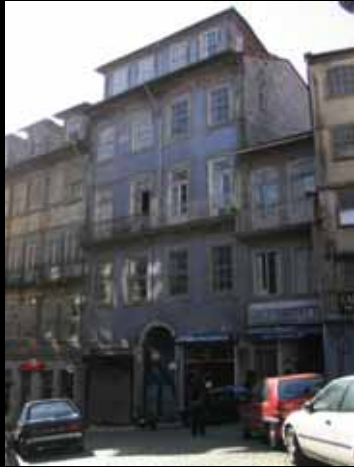
Rua dos Caldeireiros, n.º 41, 43 e 47

Preservation state: **Moderate**

Anomalies: stone incrustation; badly preserved window-frame

Observation: commerce works

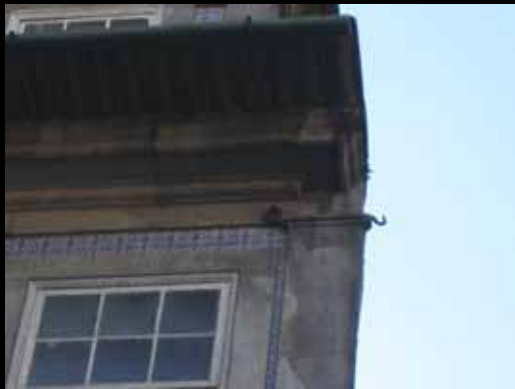
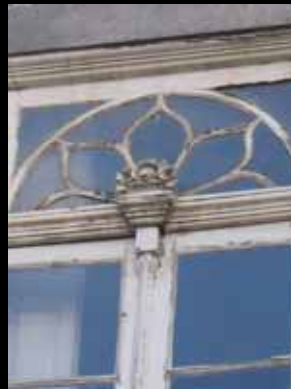
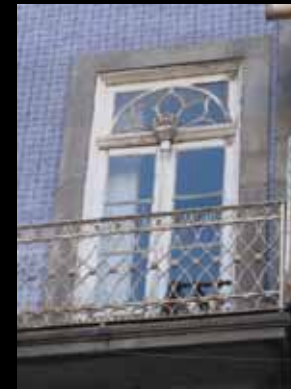
Rua dos Caldeireiros, n.º 27 e 29, 31 e 33, 35 e 37

Preservation state: **Moderate**

Anomalies: rough-cast rise up; badly preserved roof

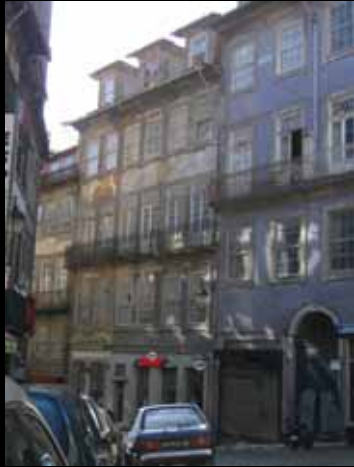
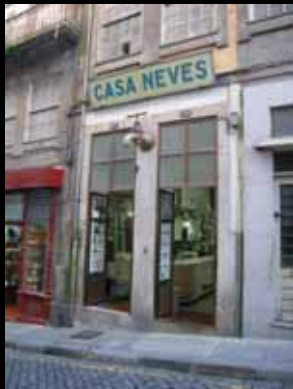
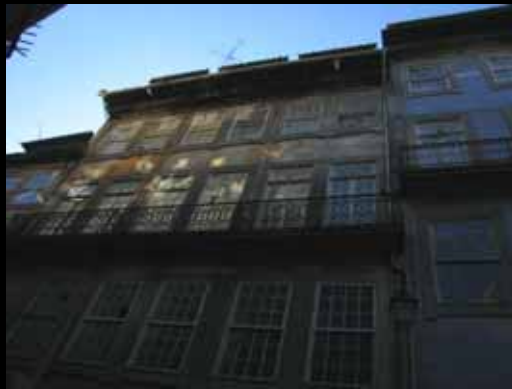
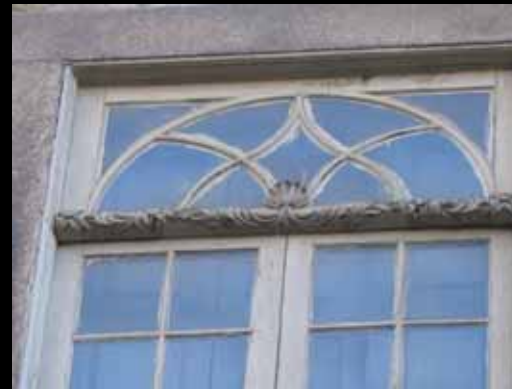
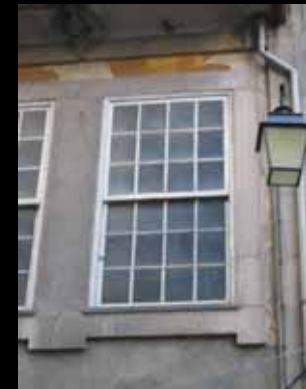
Rua dos Caldeireiros, n.º 21, 23 e 25

Preservation state: **Moderate**

Anomalies: falling tiles; unprotected masonry; vegetable colonization;
stone incrustation

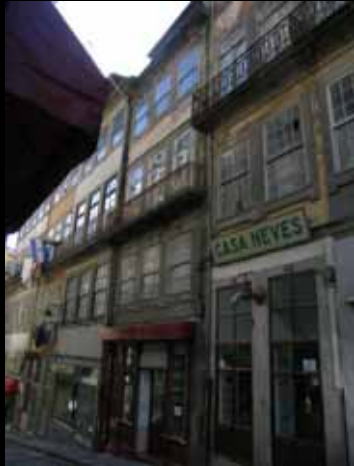
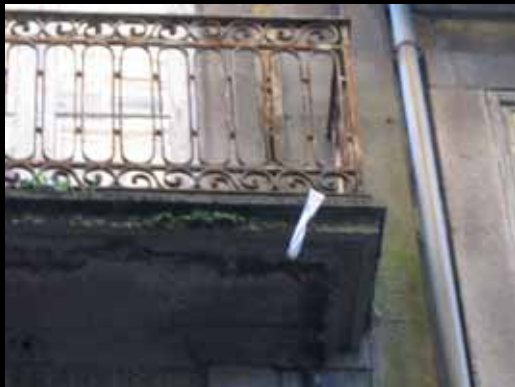
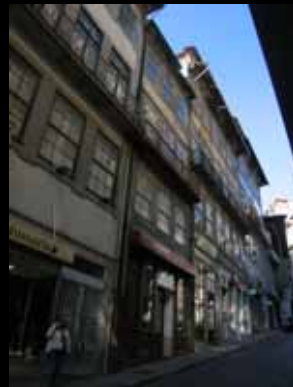
Rua dos Caldeireiros, n.º 1 e 3, 5 e 9, 15, 13 e 11, 17, 19 e 19A, gaveto com a Rua das Flores, n.º 187 e 189

Preservation state: **Moderate**

Anomalies: stone incrustation; rough-cast rise up; humidity stains; badly preserved roof
